**Prototype Testing of Improved  
Microtunnelling Pipes**

**C. C. Holt  
G. W. E. Milligan  
H. J. Burd**

University of Oxford  
Department of Engineering Science  
Parks Road  
Oxford  
OX1 3PJ

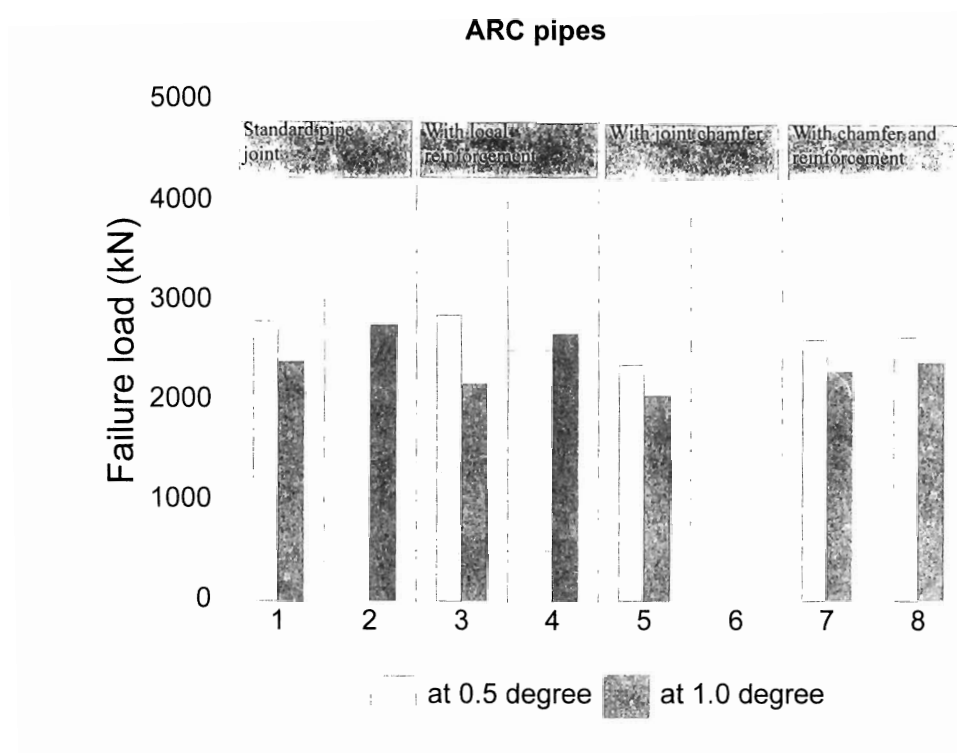
Figure 7.4 ARC pipe results

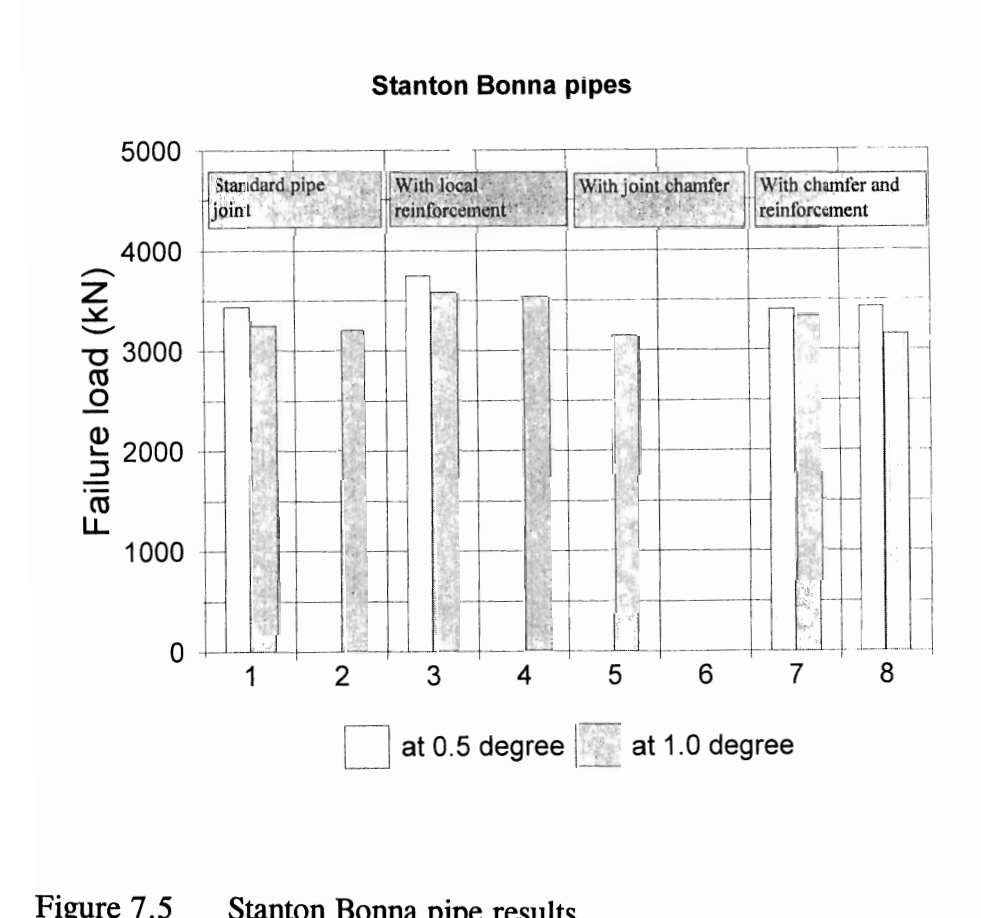
Figure 7.5 Stanton Bonna pipe results

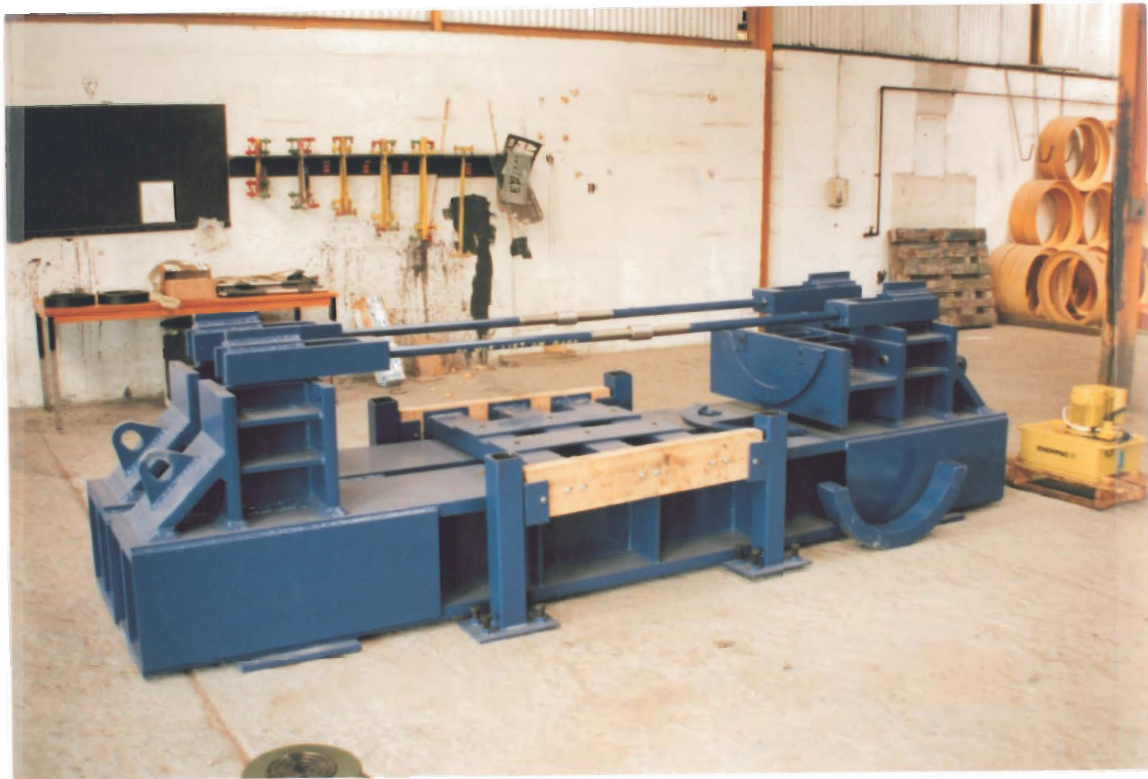
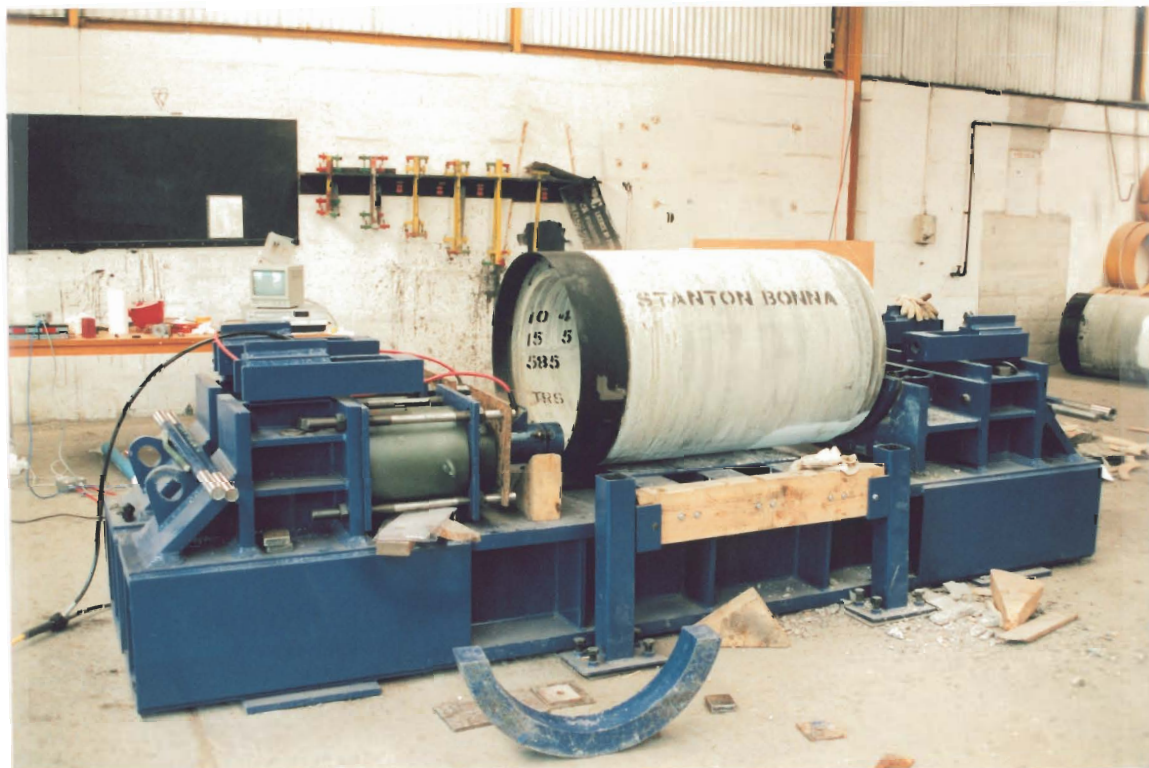
Plate 3.1 Test rig and pipe platform for DN600 microtunnelling pipes

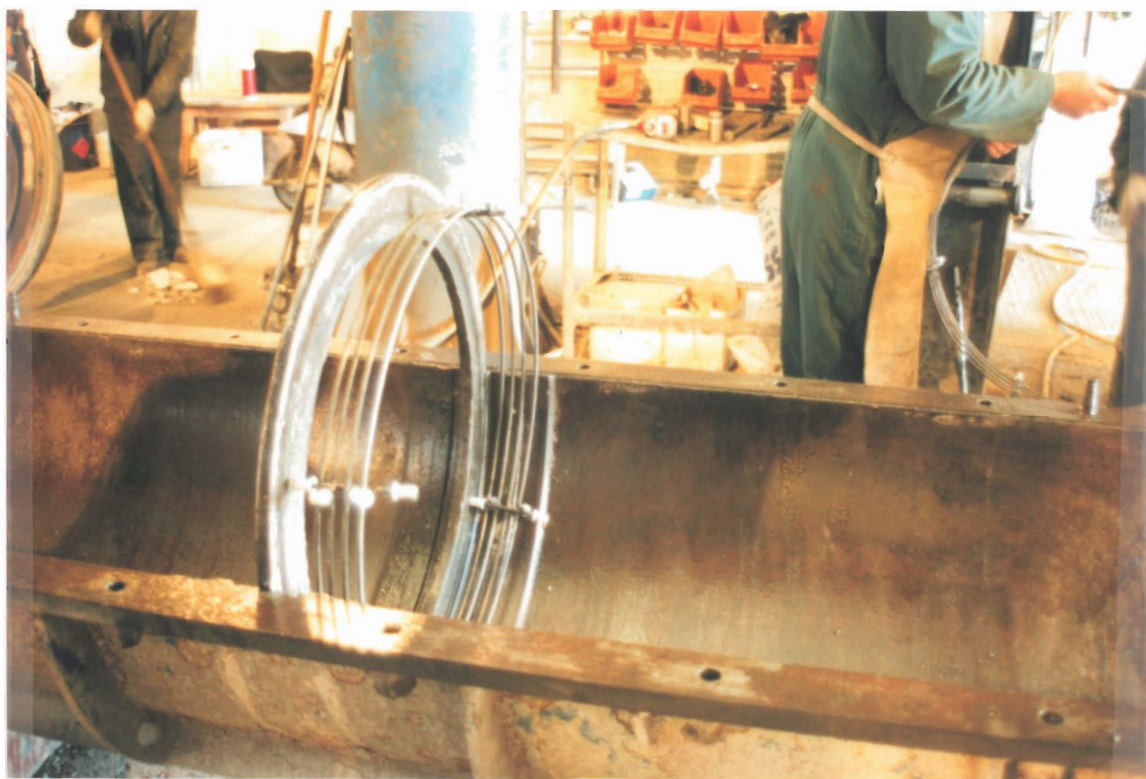
Plate 4.1      Cage of joint reinforcement in ARC DN600 pipe mould.

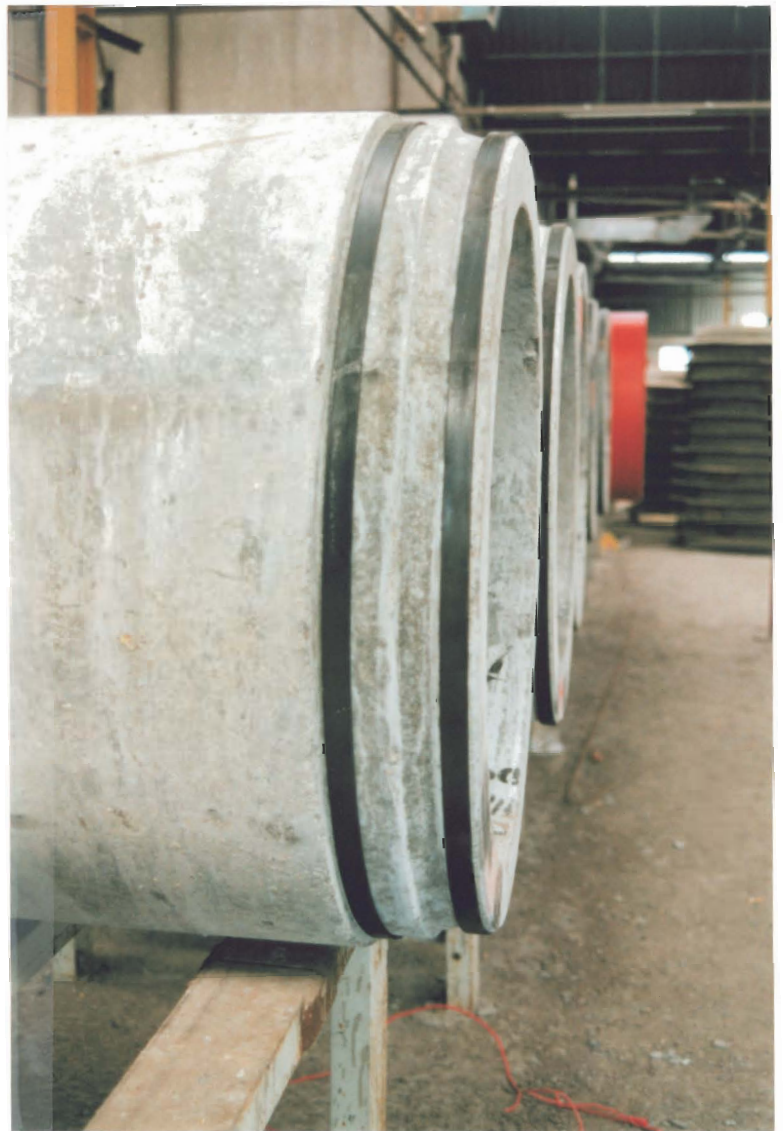
Plate 4.2      **Modifications incorporated at the spigot joint of Hepworth pipes.**

To obtain the required prestressing effect, the diameter of the steel bands needed to be slightly smaller than that of the pipe joint. Prestressing was achieved by heating the steel band, placing it over the joint and allowing it to cool. There were, however, several problems associated with this technique. Firstly, the steel band could not be heated to an excessively high temperature otherwise this could result in damage to the concrete pipe. Secondly, it was unclear how an even heat could be applied to the steel band to allow expansion to occur.

The diameter of the steel band was made 0.5mm smaller than the spigot joint of the pipe. Initial calculations suggested that a temperature of approximately 150°C would cause an expansion of 0.8mm. Contraction of this band would then result in a prestress of approximately 140 N/mm<sup>2</sup>. Dimensions of the prestressing bands are given in Table 4.3. The stresses listed in Table 4.3 are based on pipe measurements taken at Hepworths pipe works.

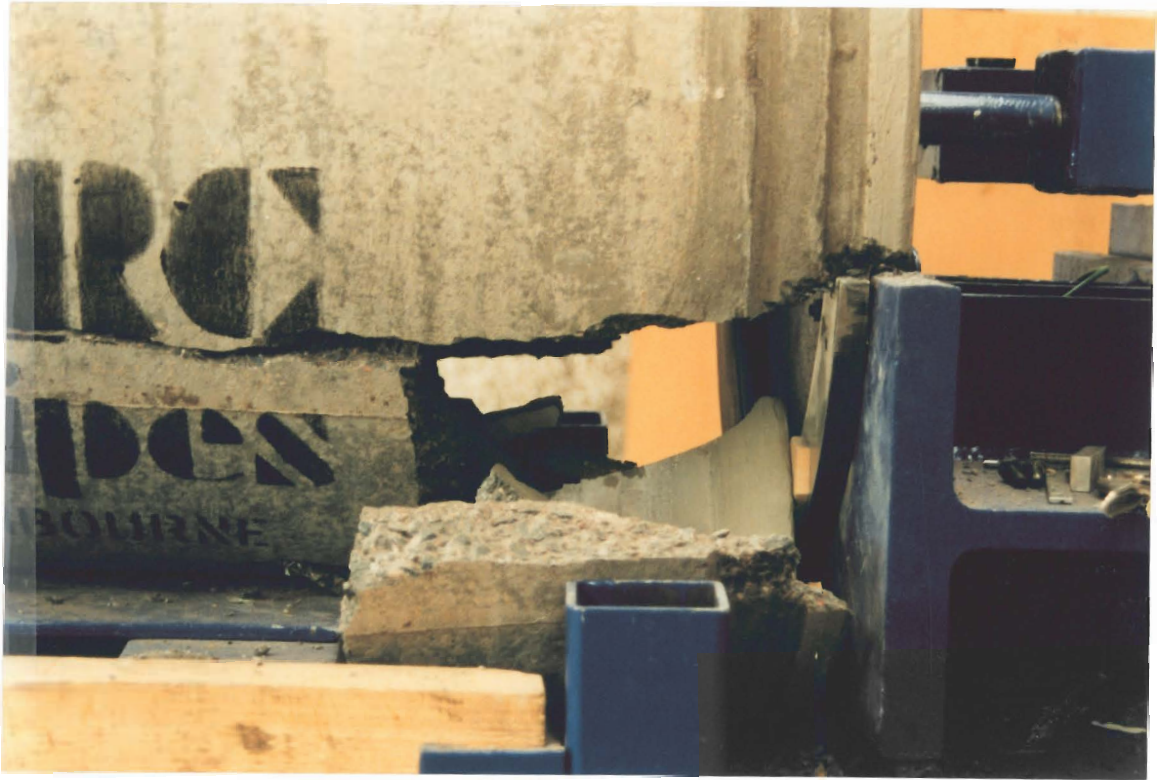
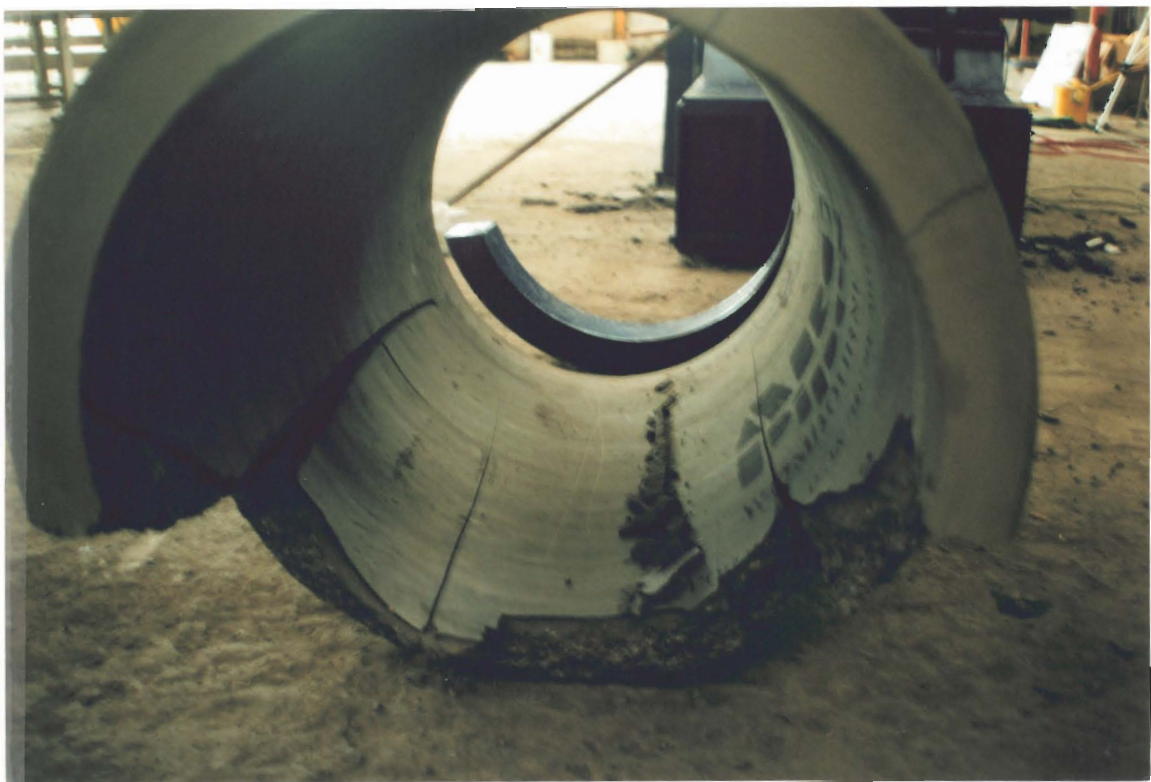
Plate D1 Pipe 2: Standard production with 3° chamfer (0.5° deflection)

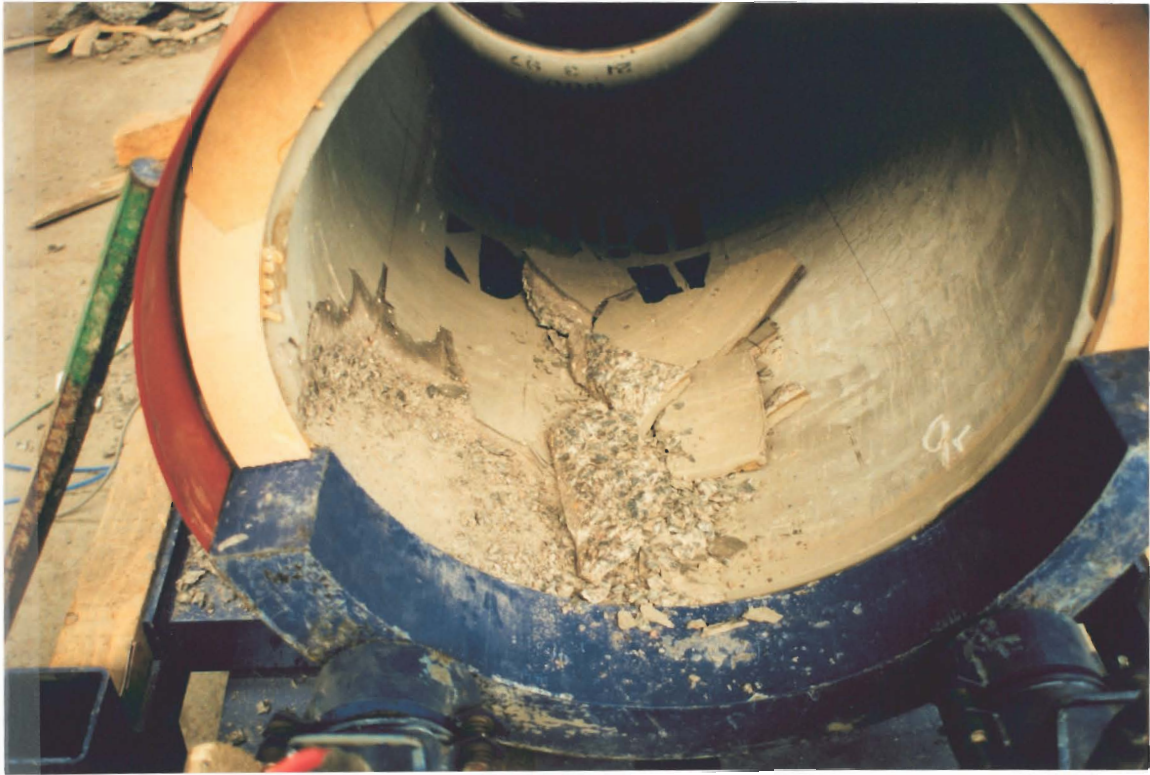
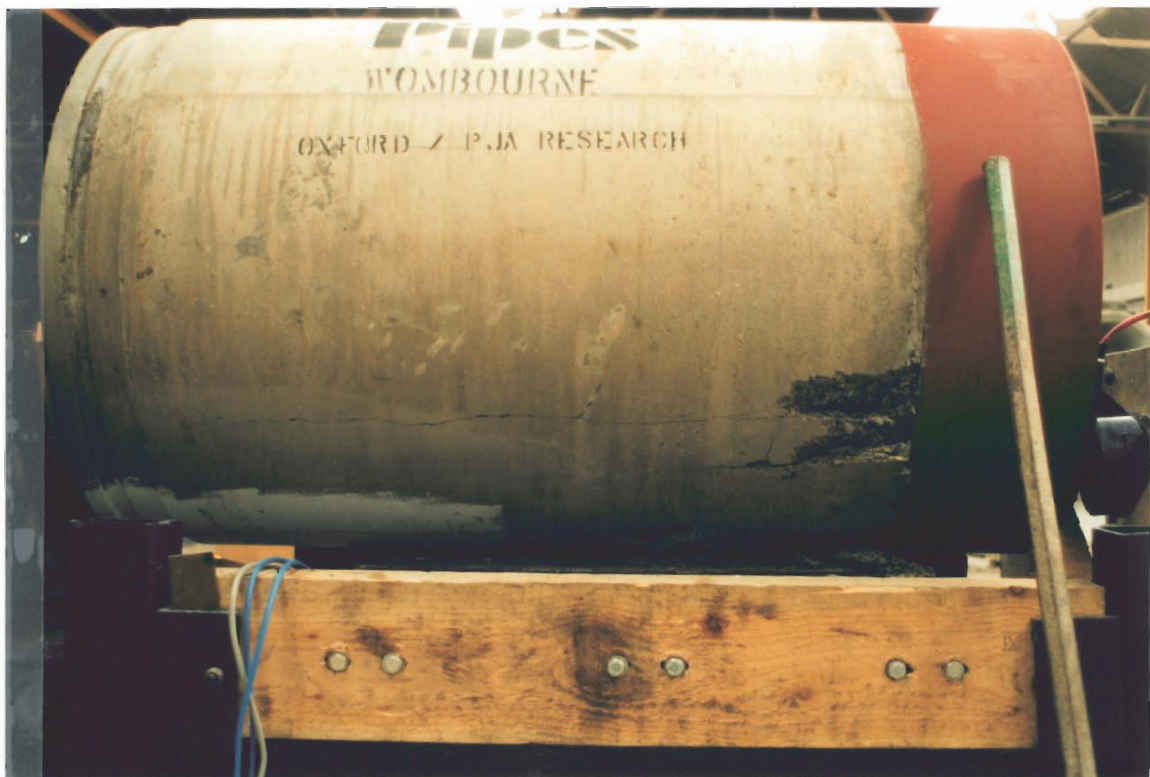
Plate D2 Pipe 3: Standard pipe with joint reinforcement ( $0.5^\circ$  deflection)

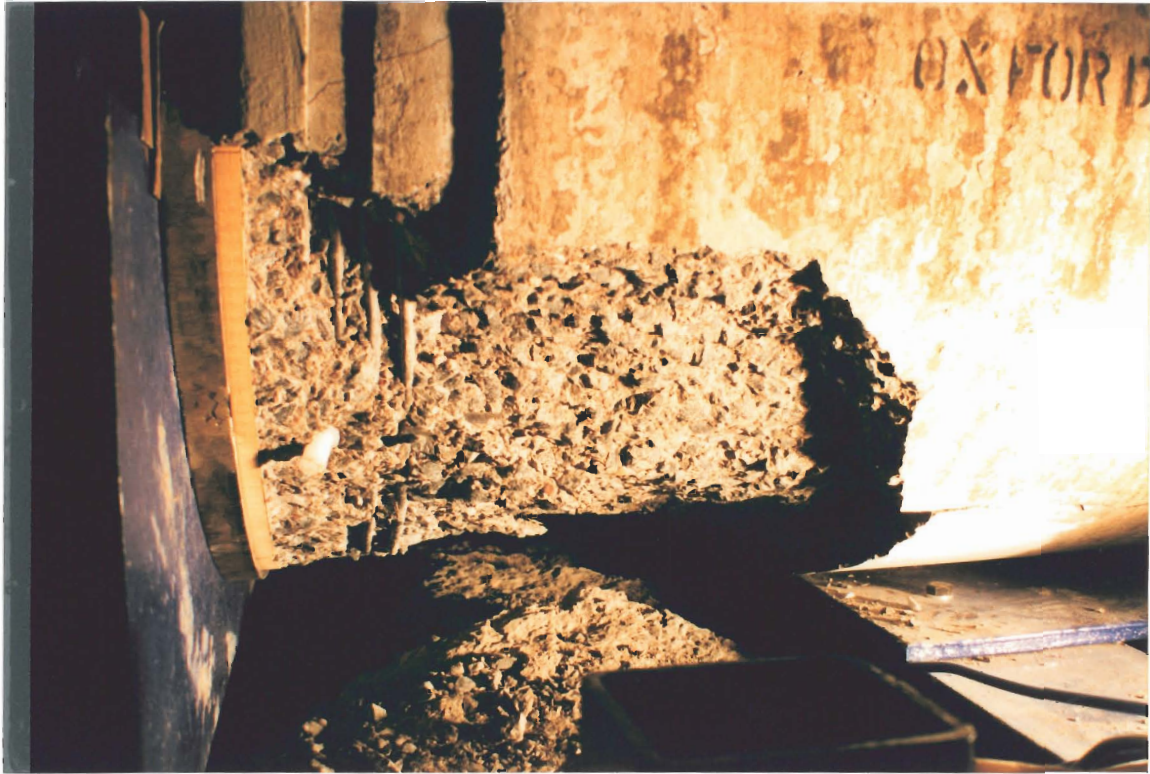
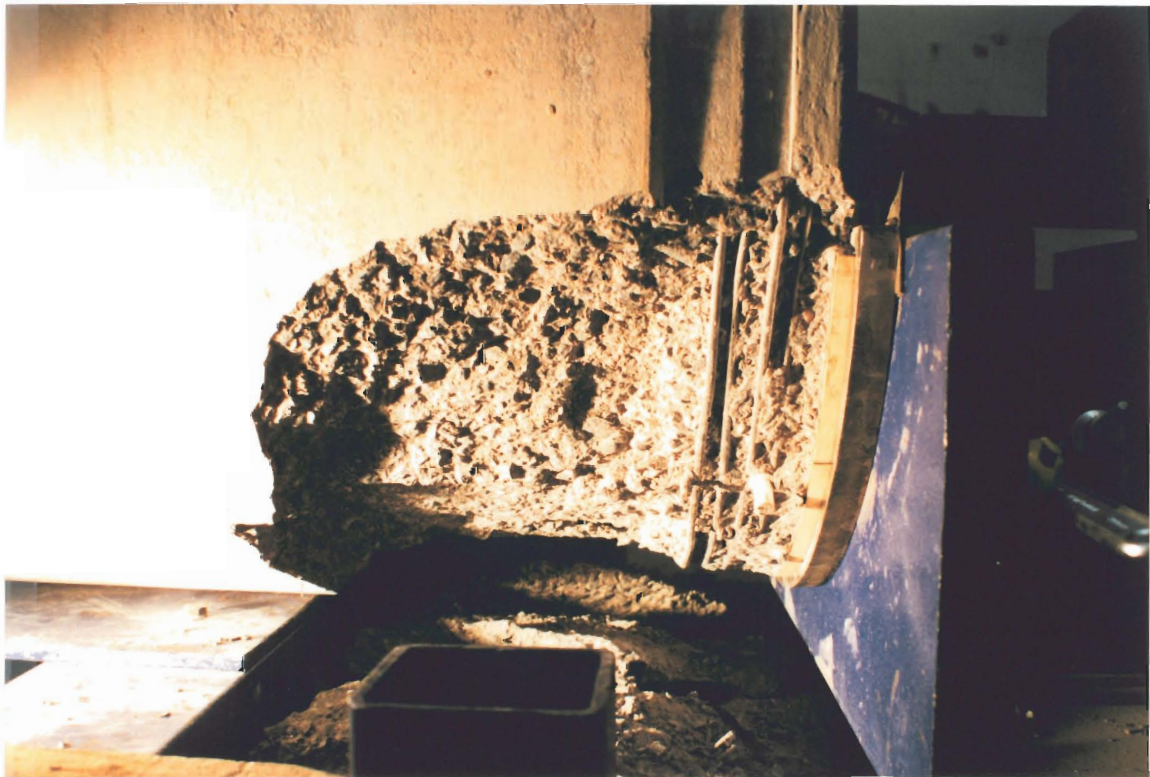
Plate D3 Pipe 4: Standard pipe with 3° and joint reinforced chamfer (0.5° deflection)

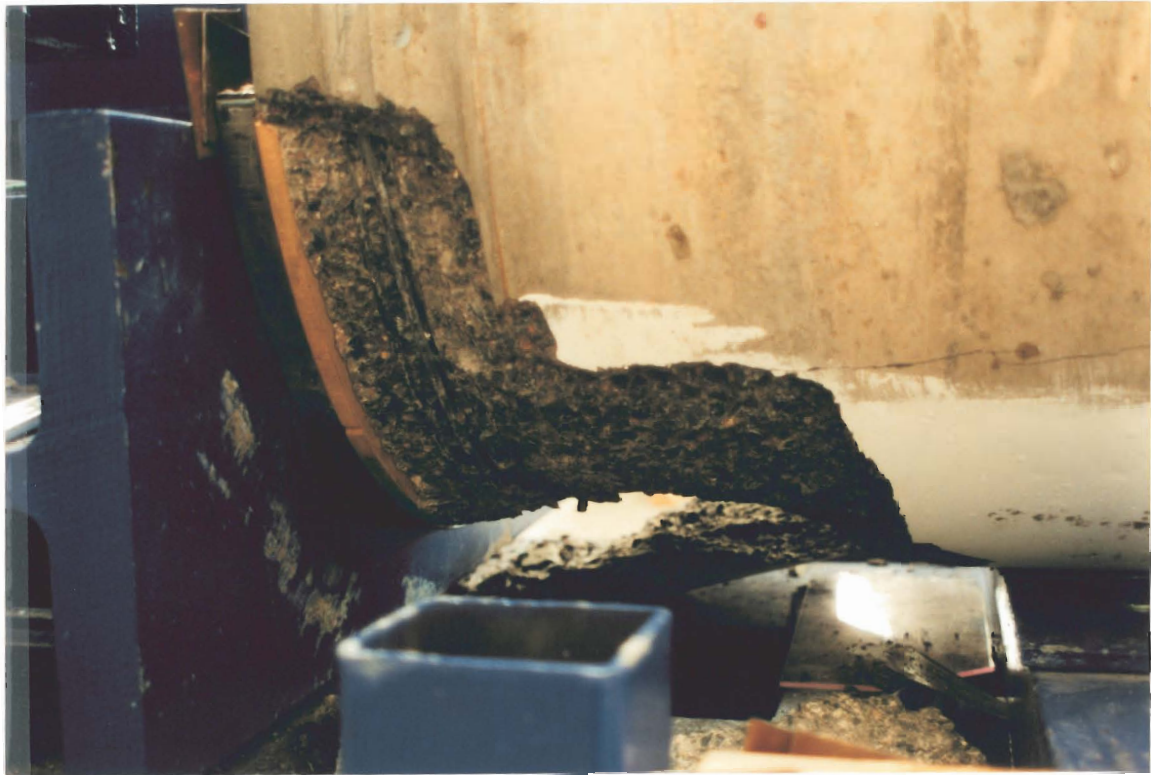
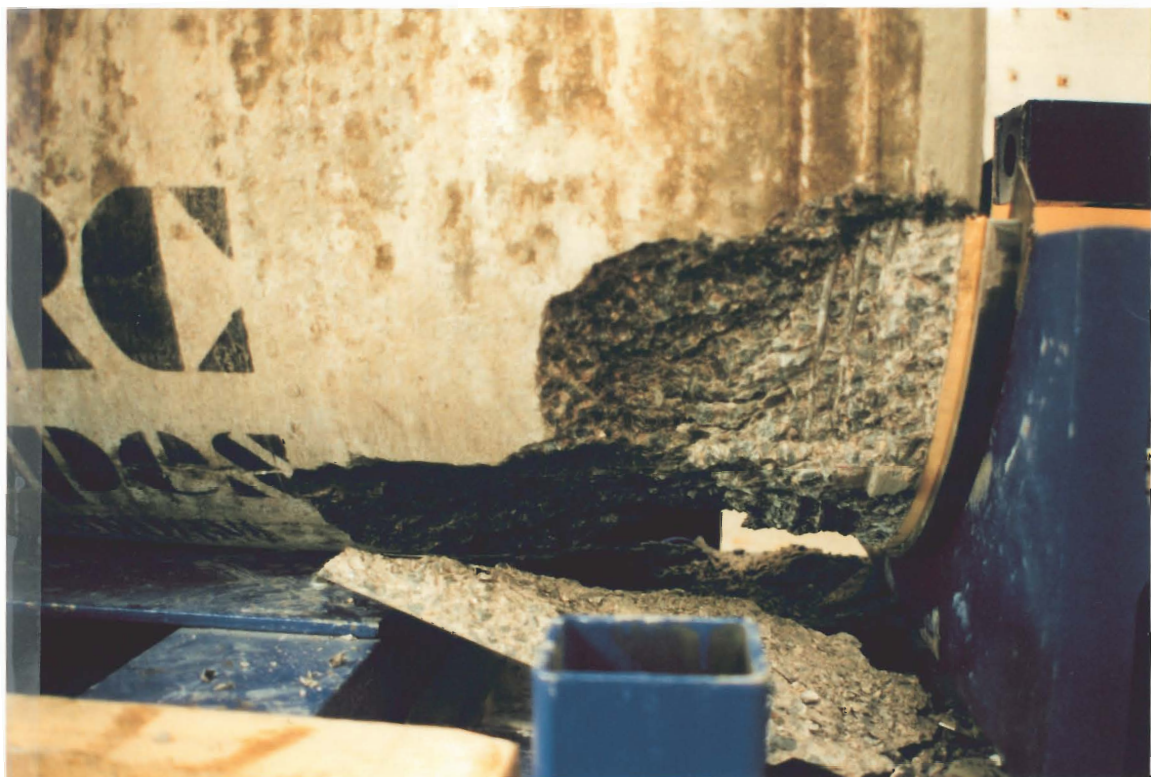
Plate D4 Pipe 5: Standard pipe with 3° chamfer and joint reinf't (0.5° deflection)

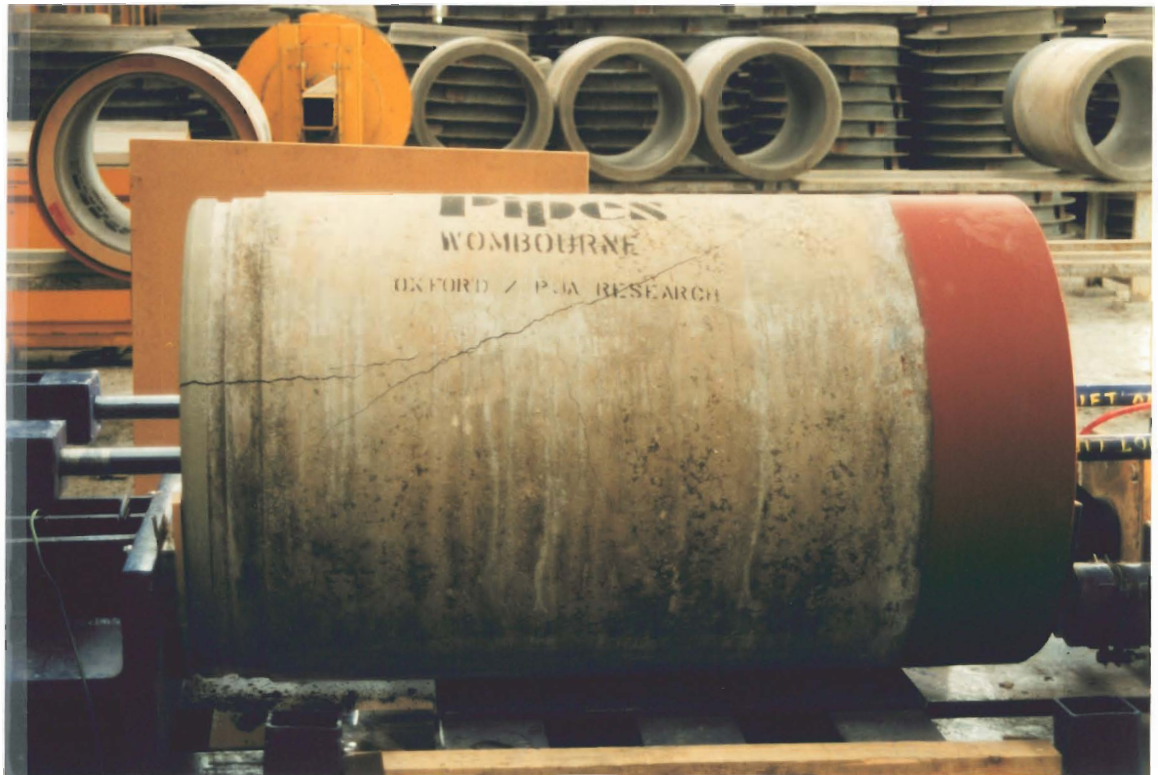
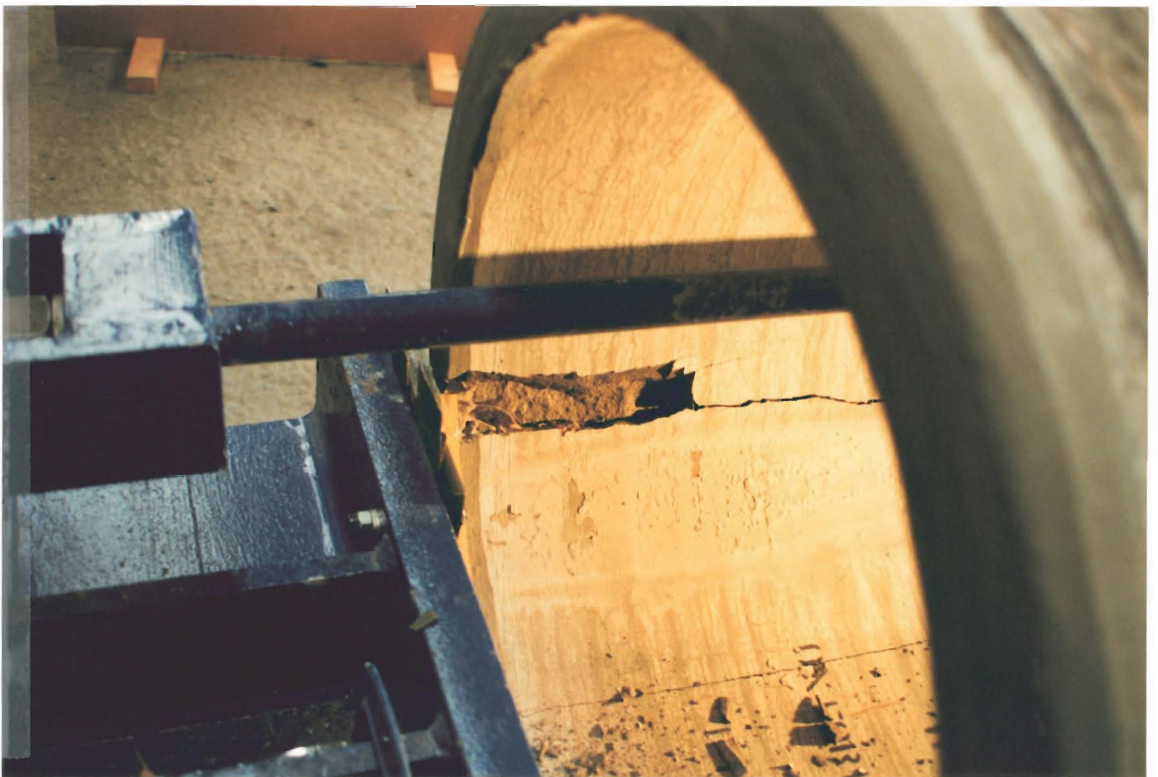
Plate D5 Pipe 6: Standard pipe ( $1.0^\circ$  deflection)

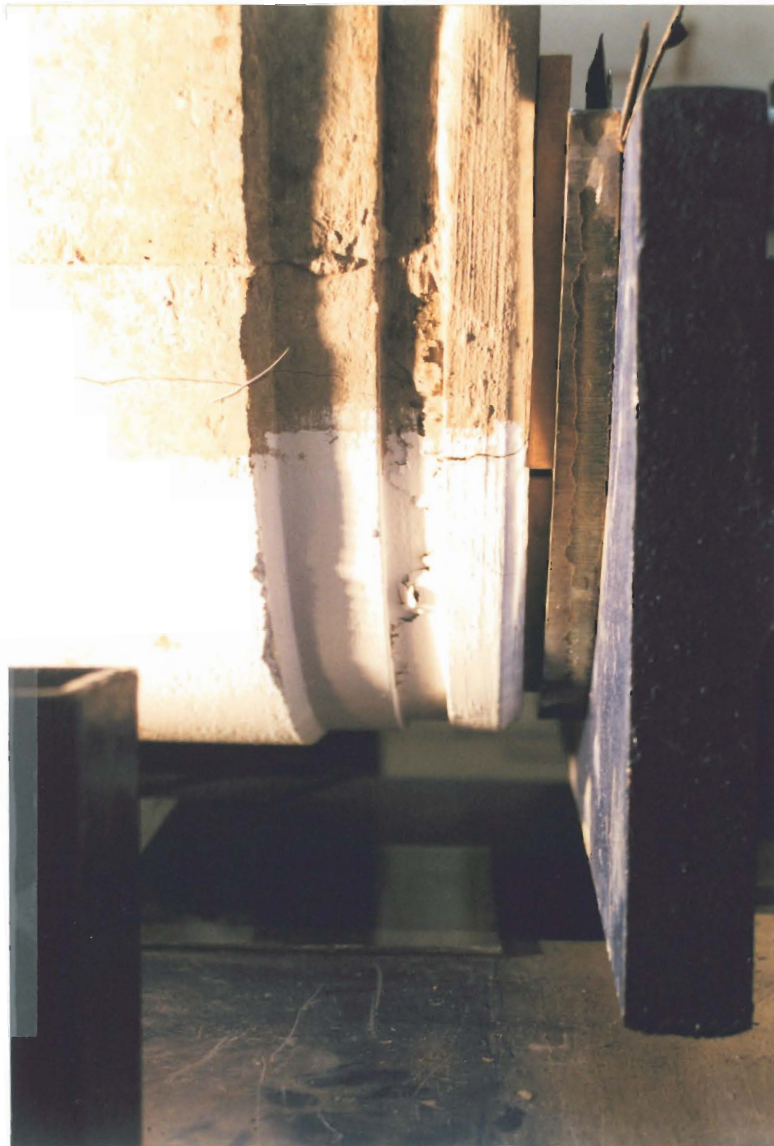
Plate D6 Pipe 7: Standard pipe ( $1.0^\circ$  deflection)

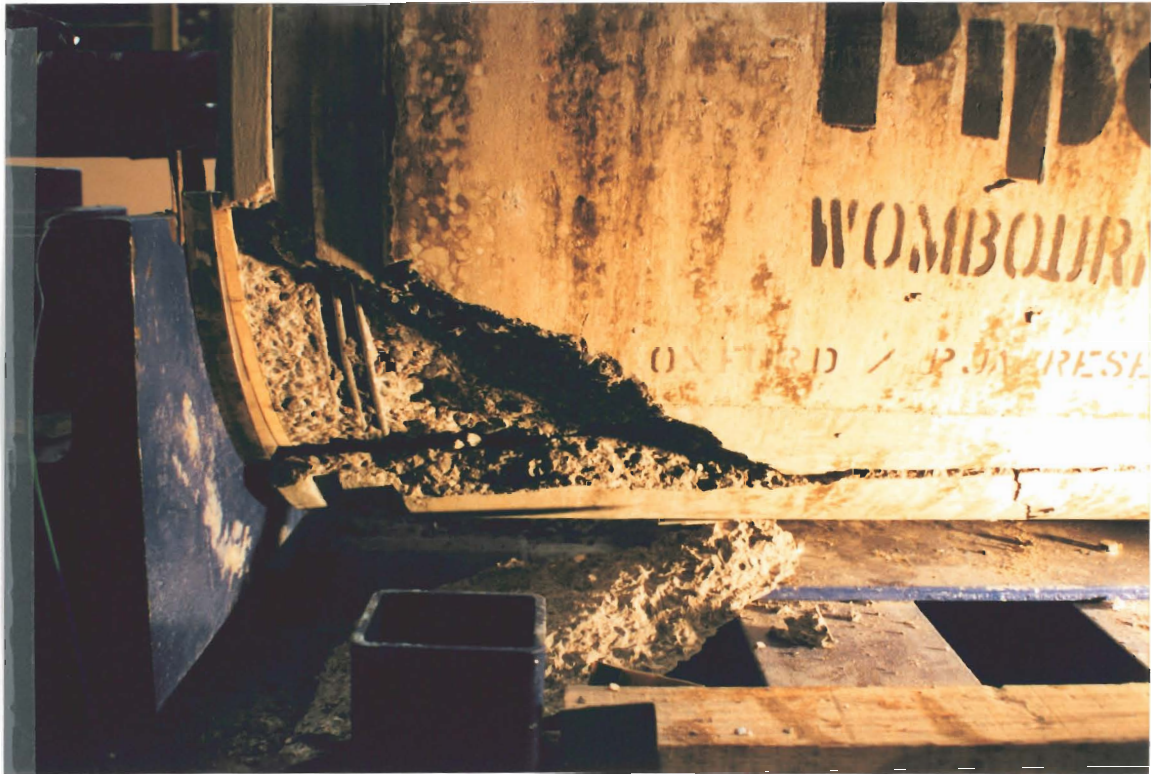
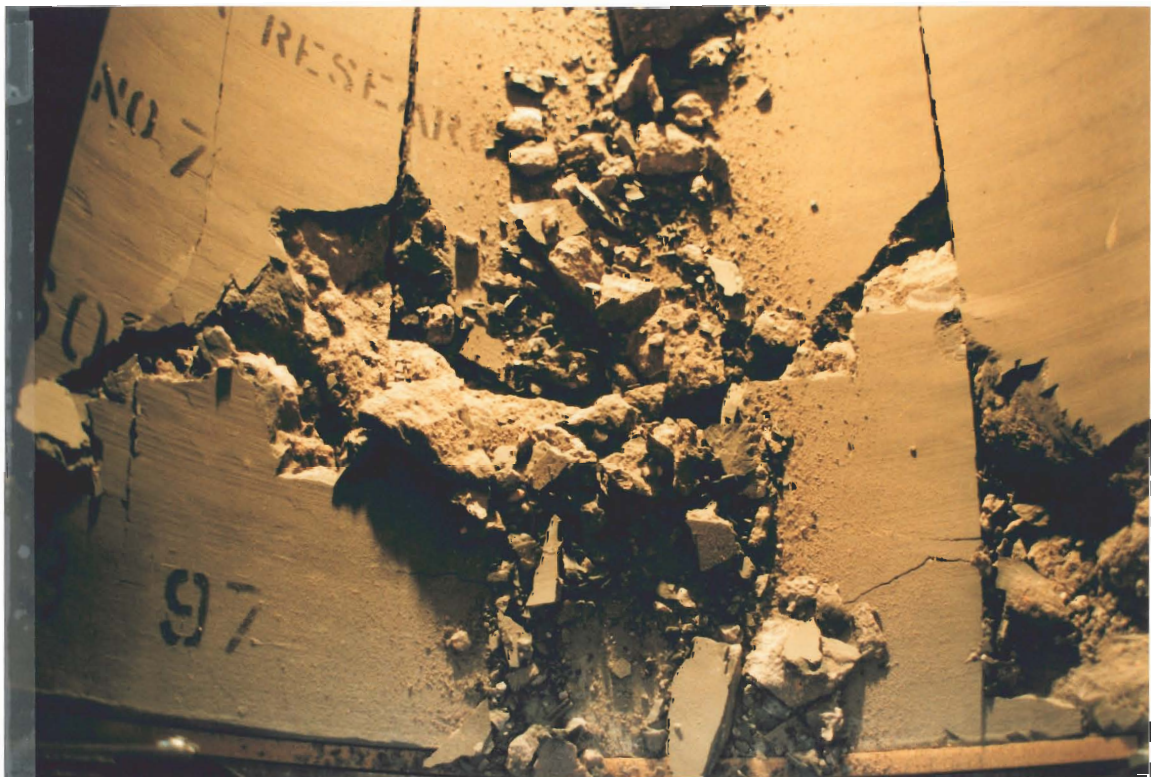
Plate D7 Pipe 9: Standard pipe with joint reinforcement ( $1.0^\circ$  deflection)

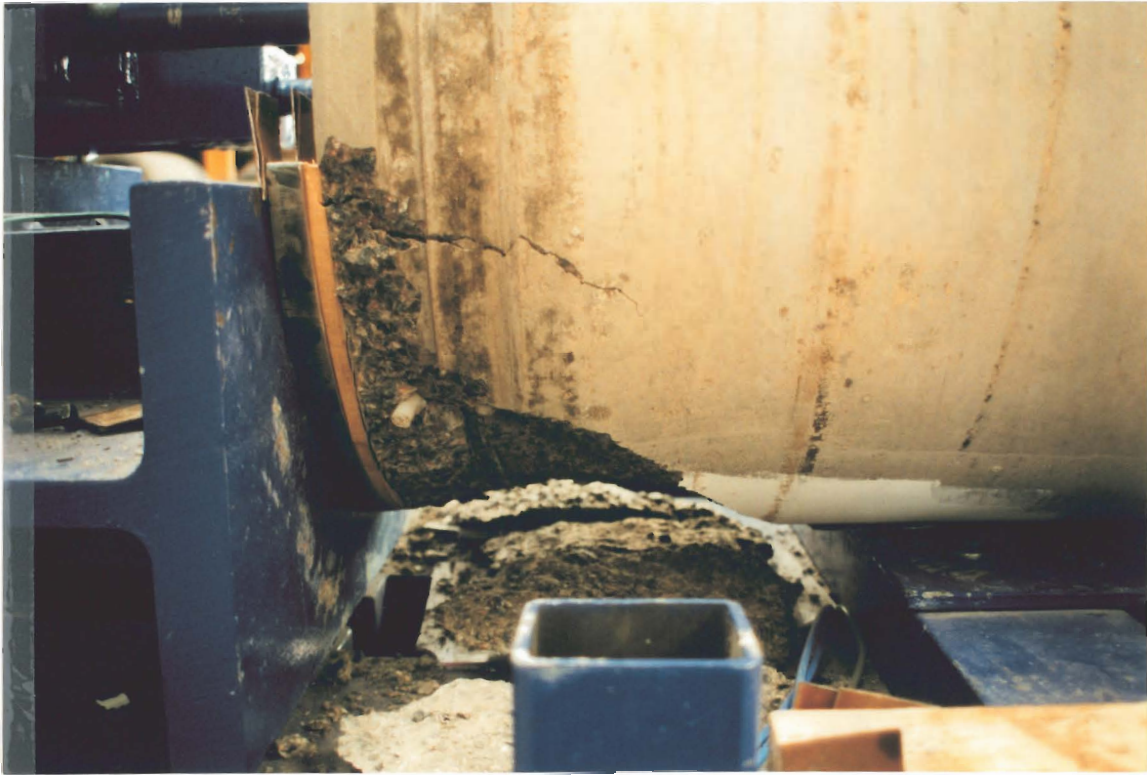
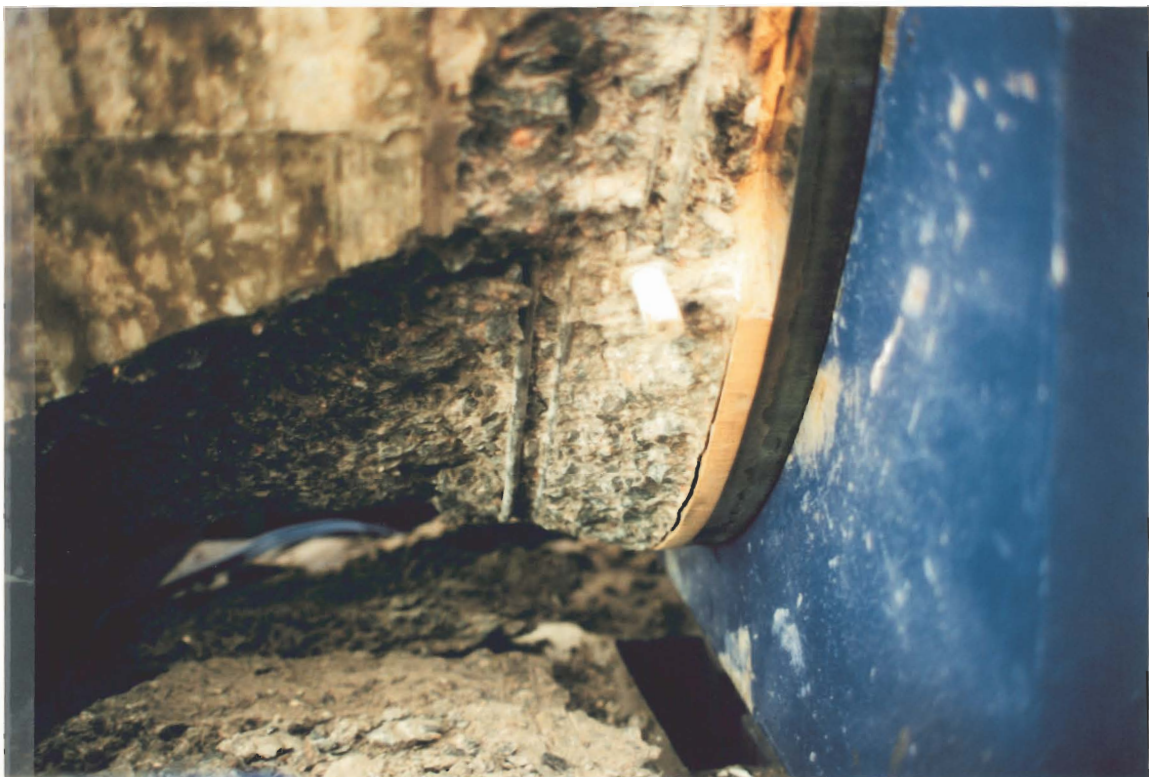
Plate D8 Pipe 10: Standard pipe with joint reinforcement (1.0° deflection)

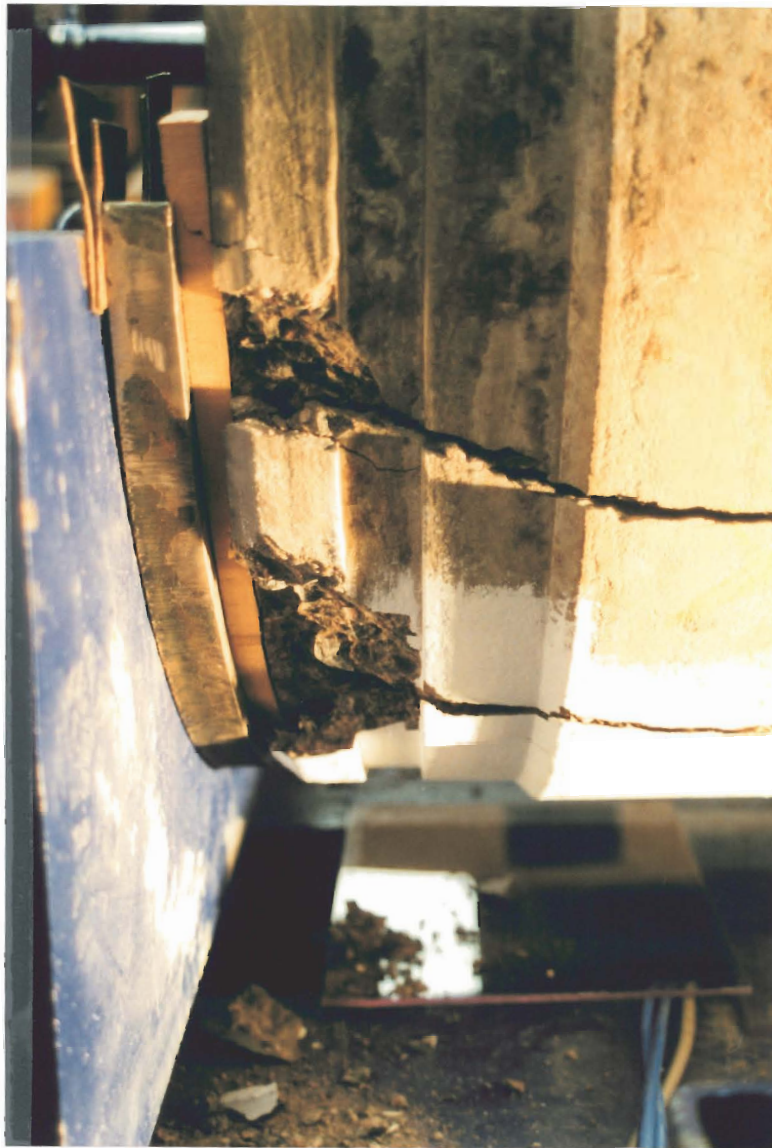
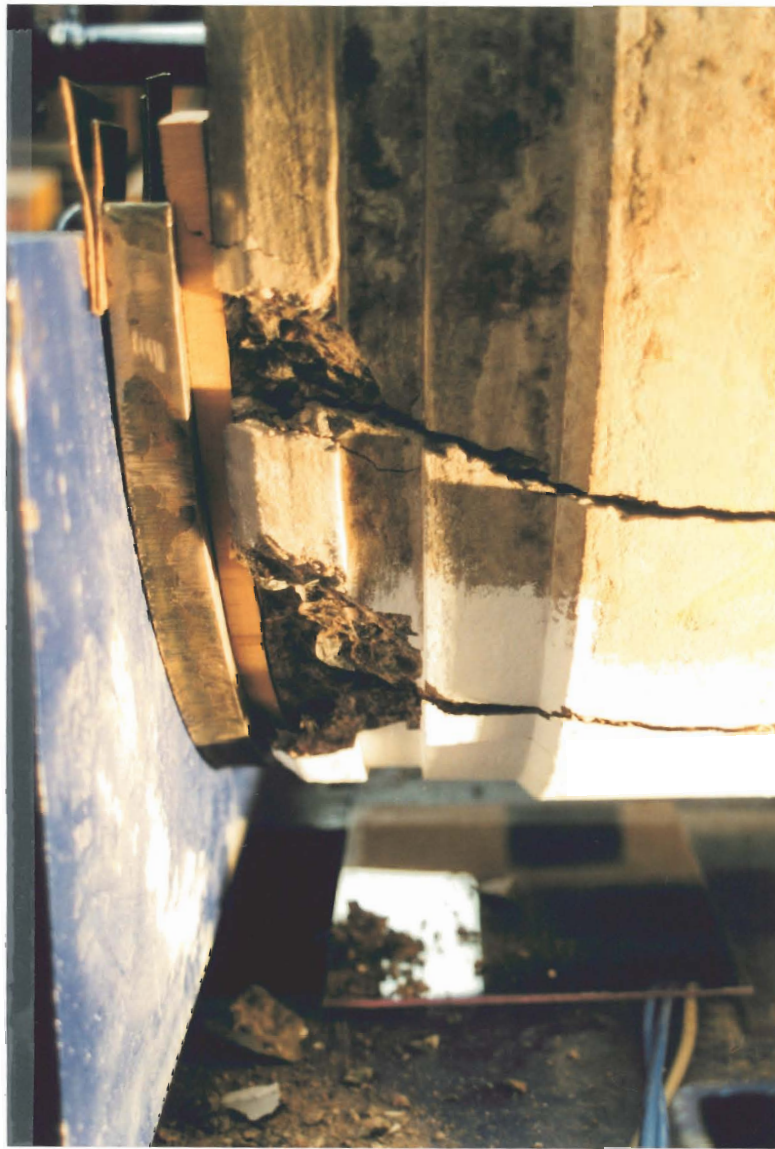
Plate D9 Pipe 11: Standard pipe with 3° chamfer and joint reinft (1.0° deflection)

Plate D9 Pipe 11: Standard pipe with 3° chamfer and joint reinf't (1.0° deflection)

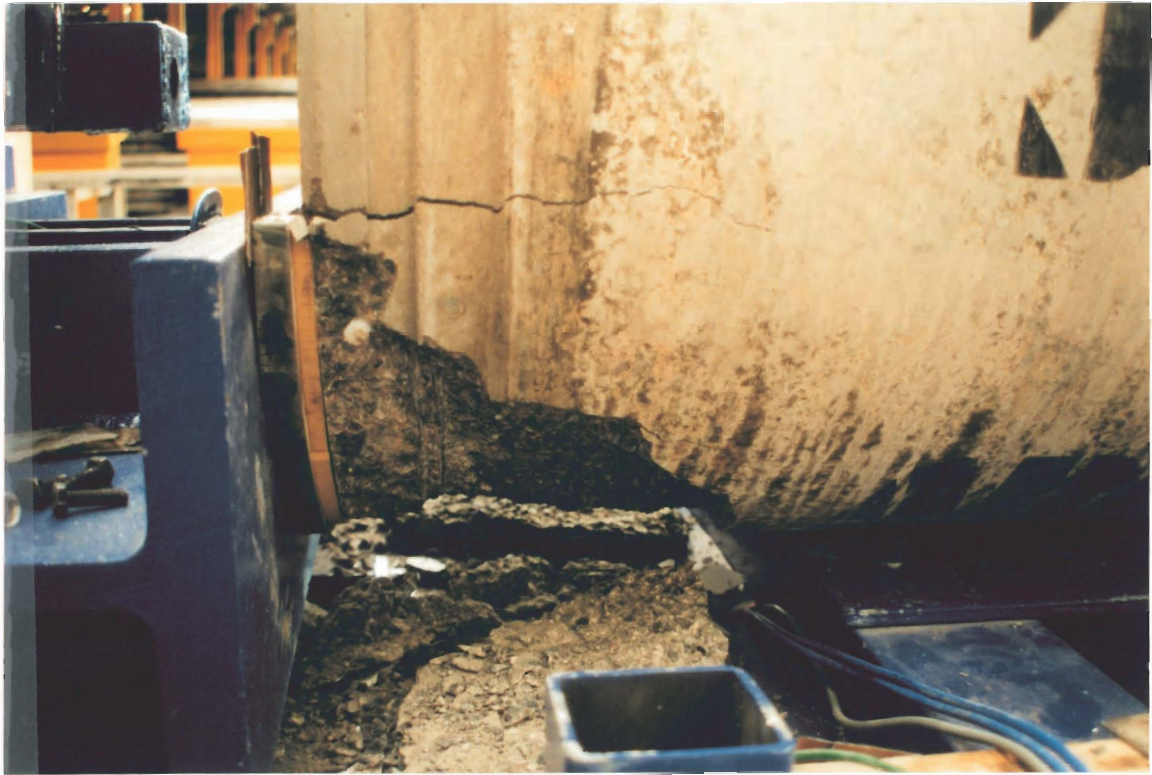
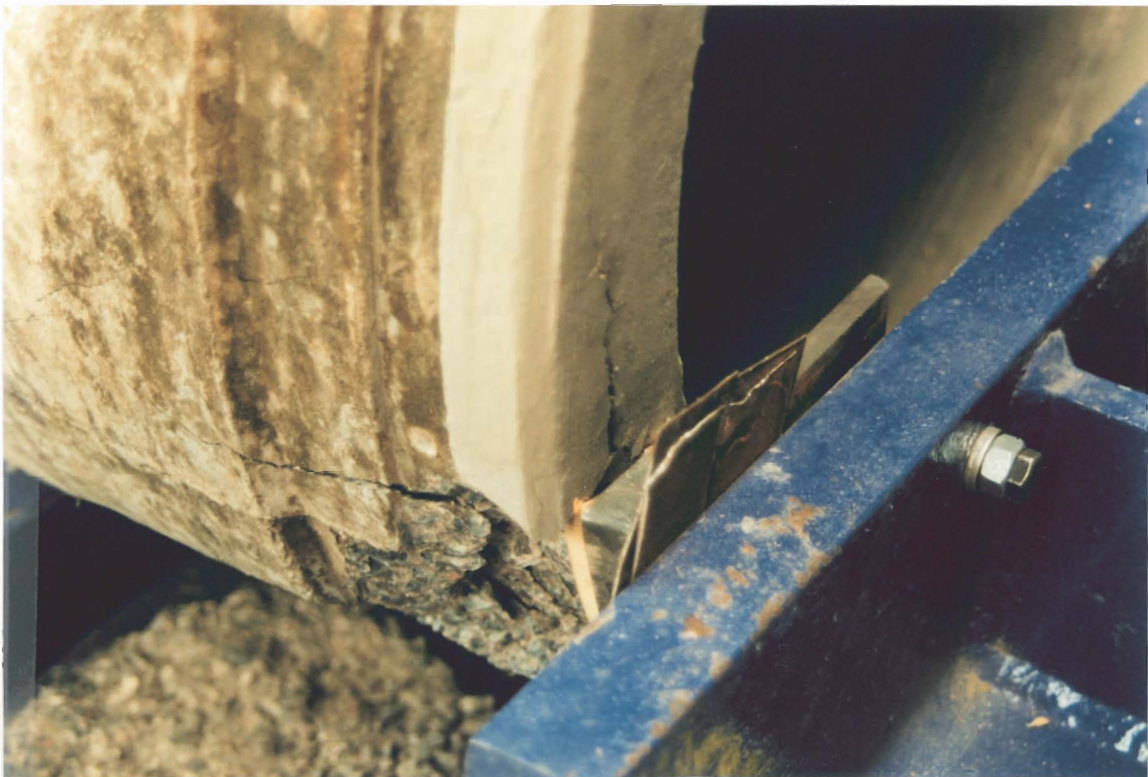
Plate D10 Pipe 12: Standard pipe with 3° chamfer and joint reinft (1.0° deflection)
