**Prototype Testing of Improved  
Microtunnelling Pipes**

**C. C. Holt  
G. W. E. Milligan  
H. J. Burd**

University of Oxford  
Department of Engineering Science  
Parks Road  
Oxford  
OX1 3PJ

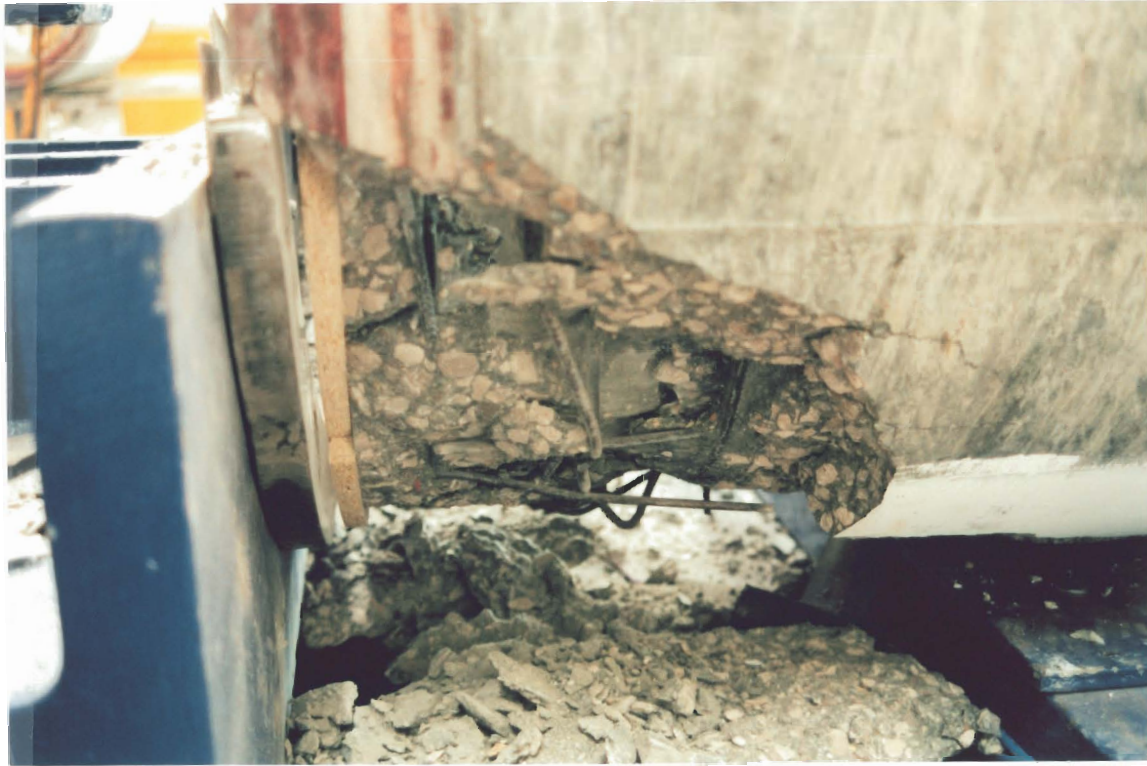
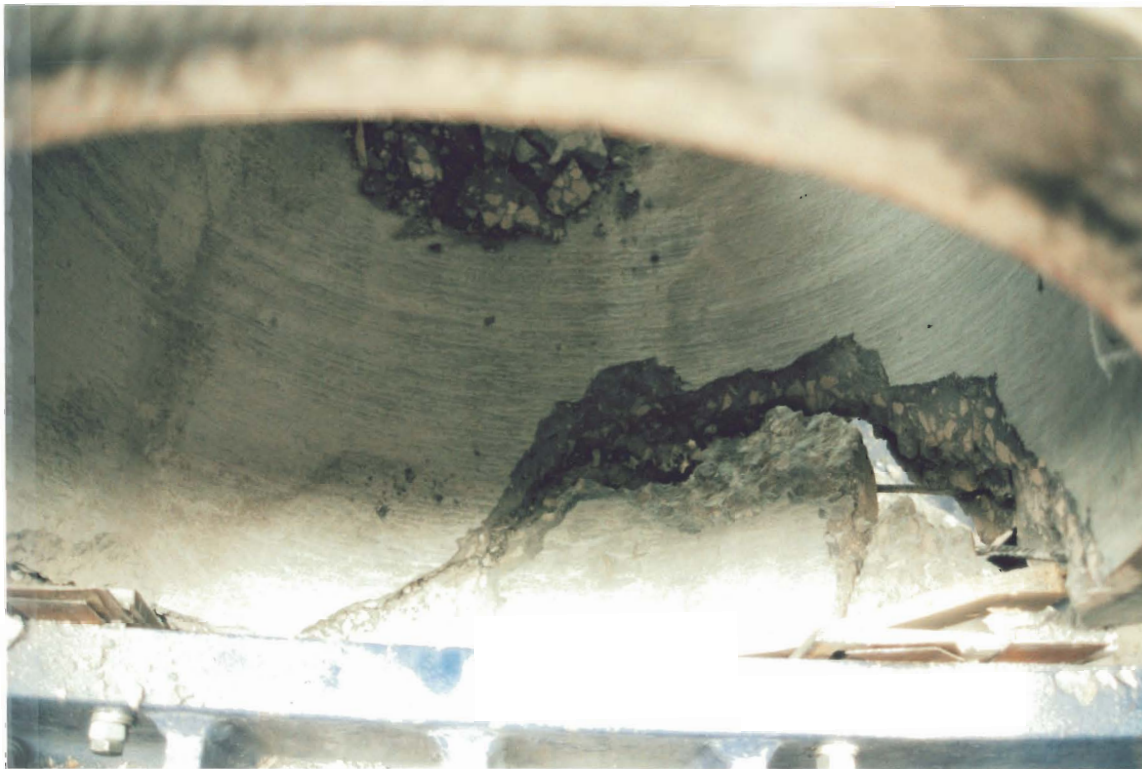
Plate D12 Pipe 2: Standard pipe with 2° chamfer (0.5° deflection)

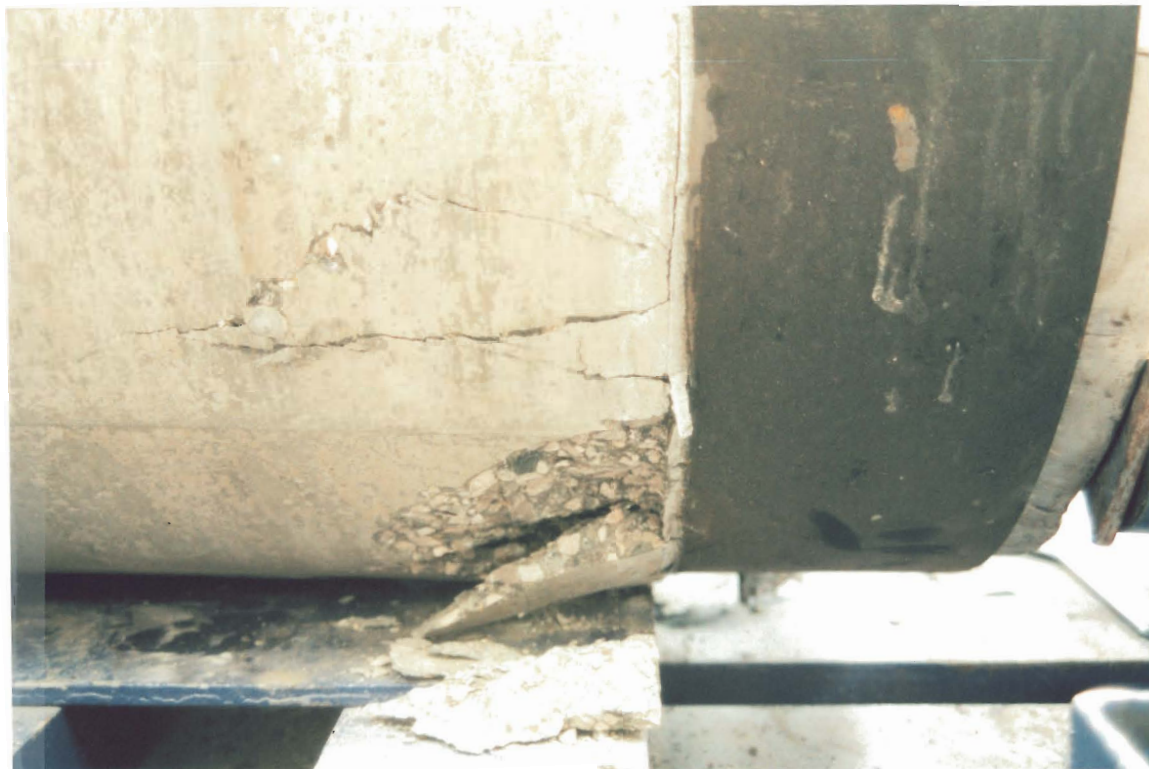
Plate D13 Pipe 3: Pipe with joint reinforcement (0.5° deflection)

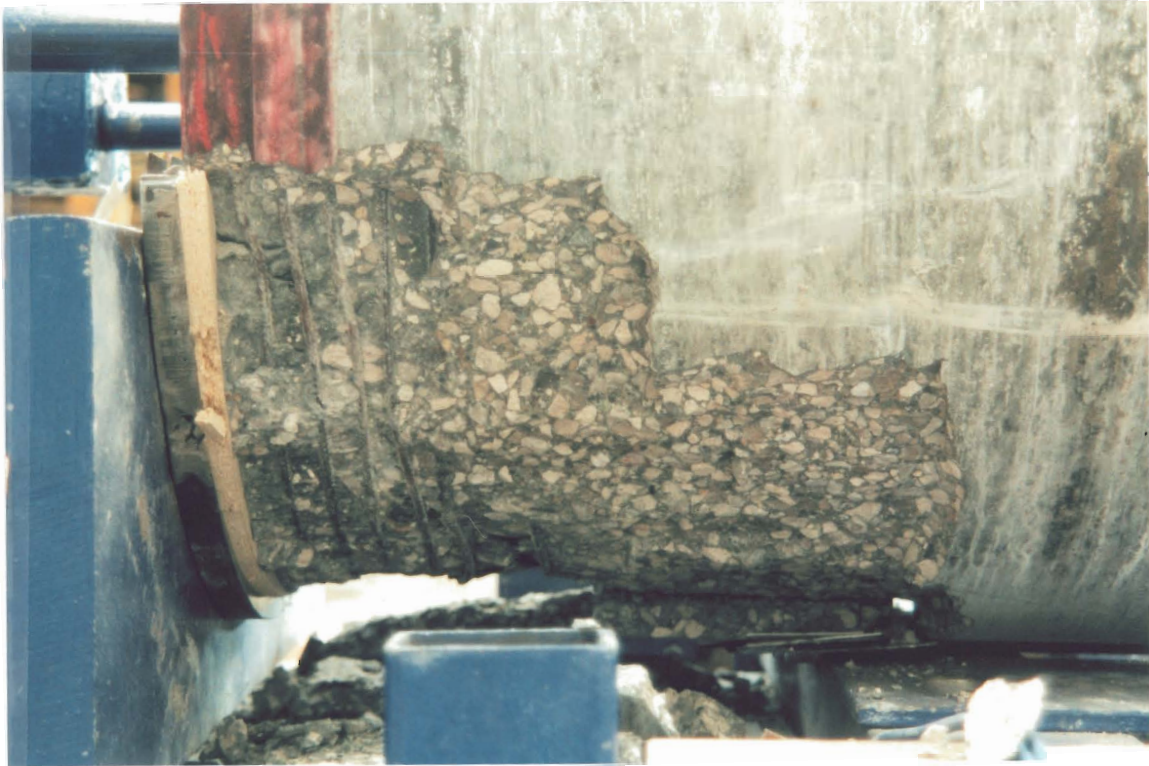
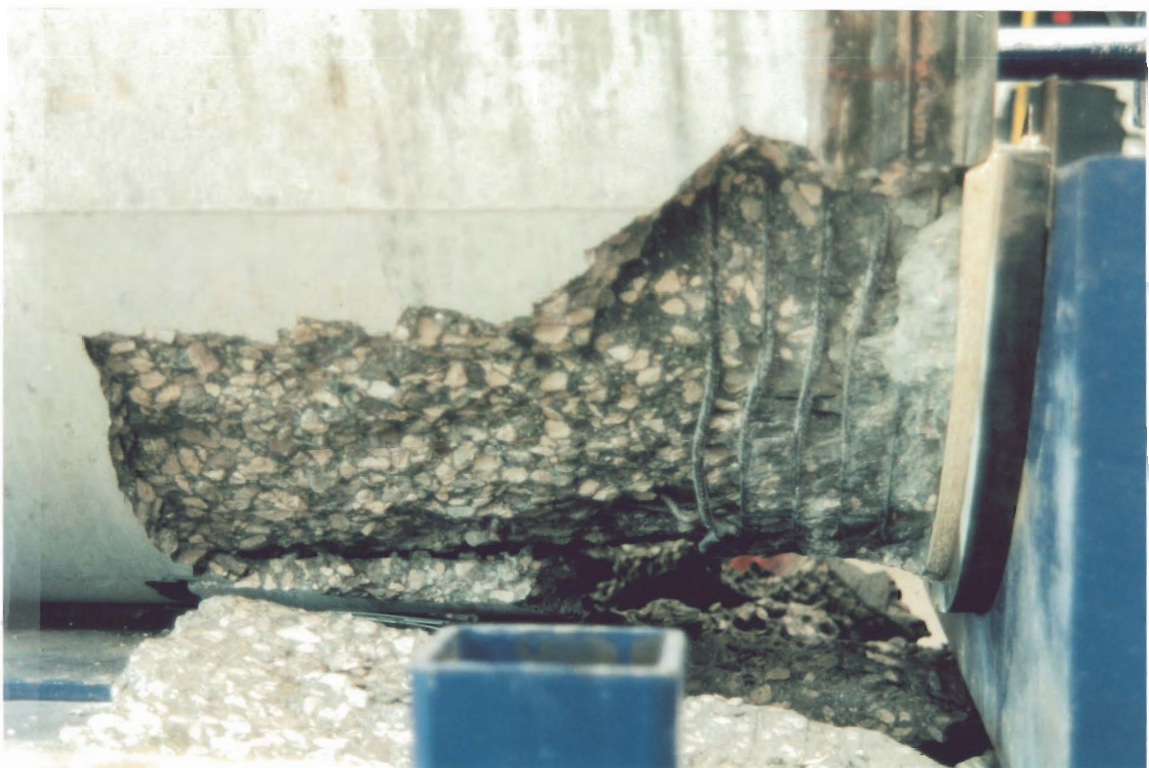
Plate D14 Pipe 4: Standard pipe with 3° chamfer and joint reinf't (0.5° deflection)

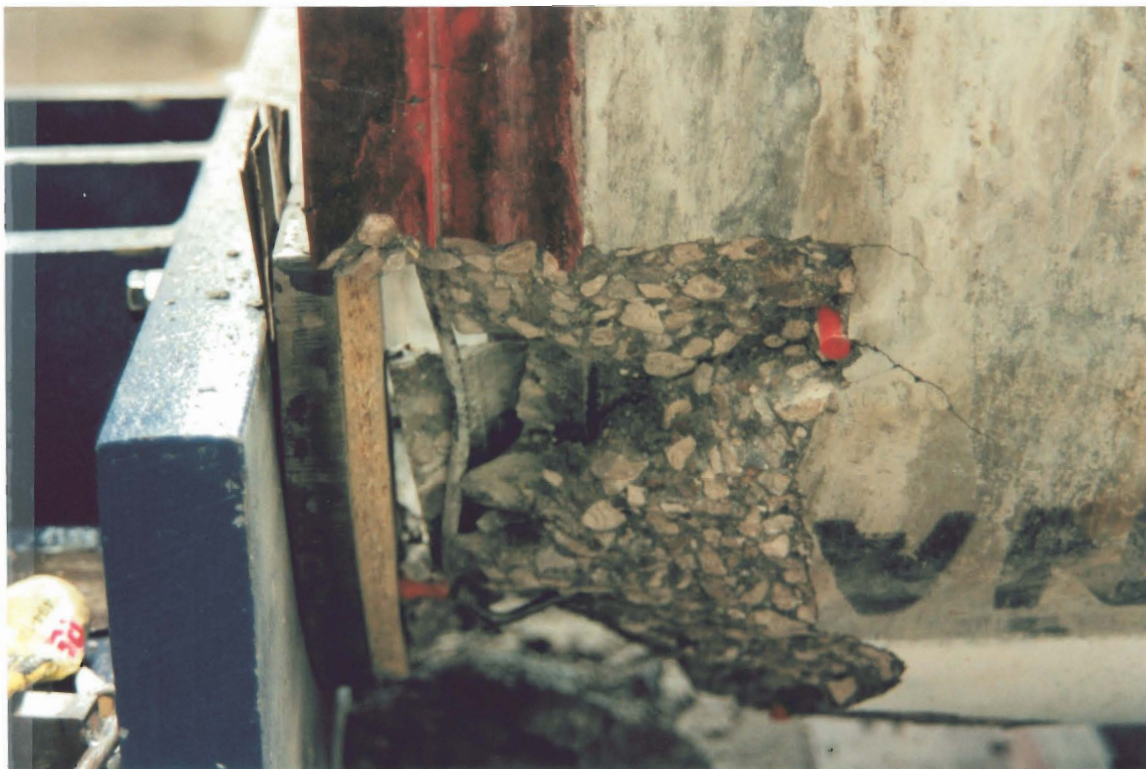
Plate D16 Pipe 6: Standard pipe (1.0° deflection)

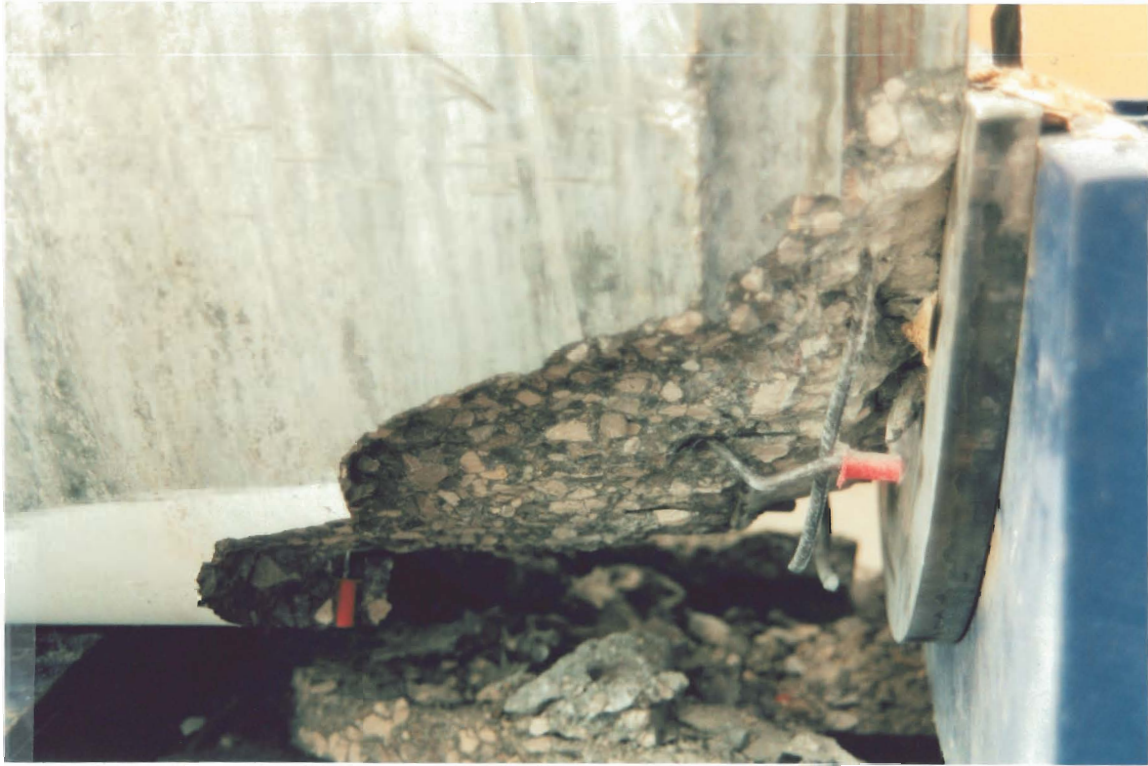
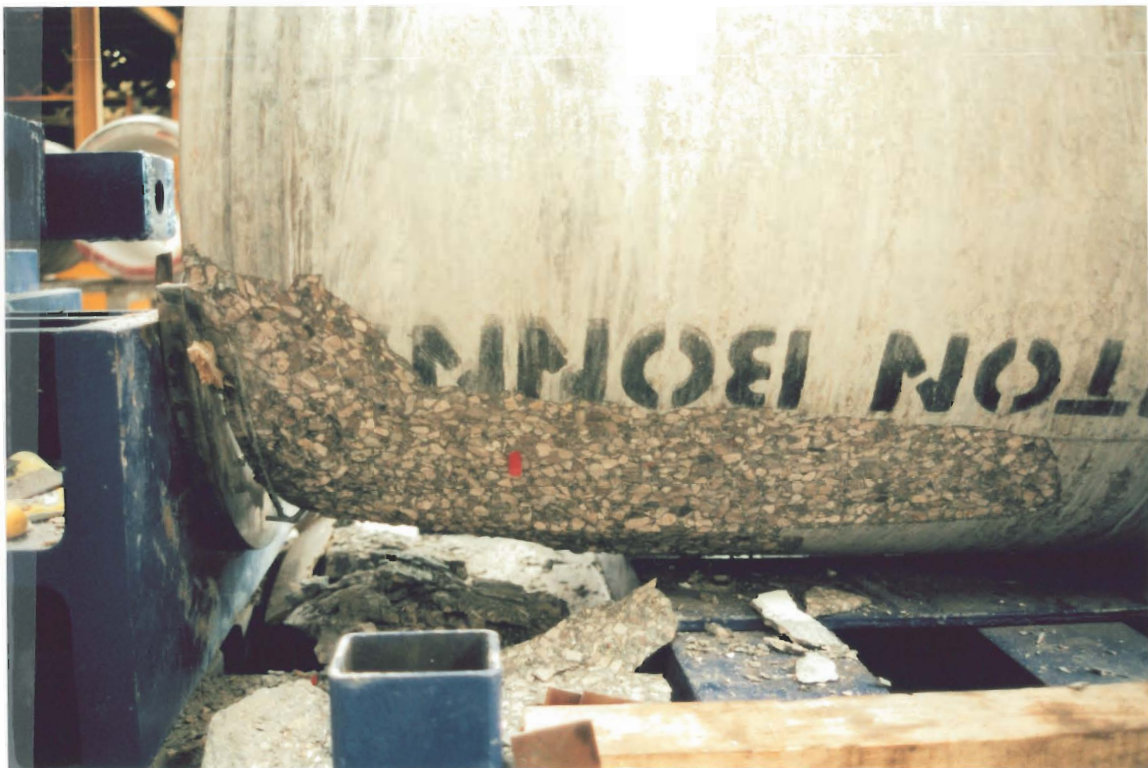
Plate D17 Pipe 7: Standard pipe (1.0° deflection)

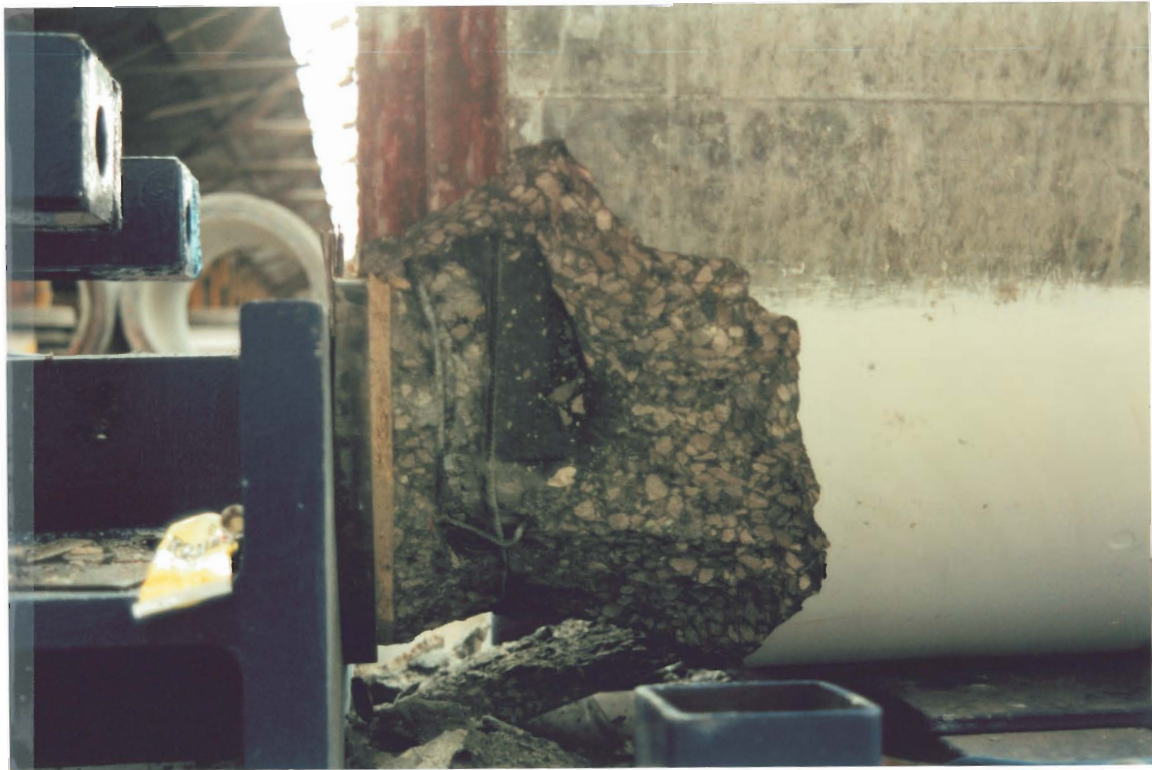
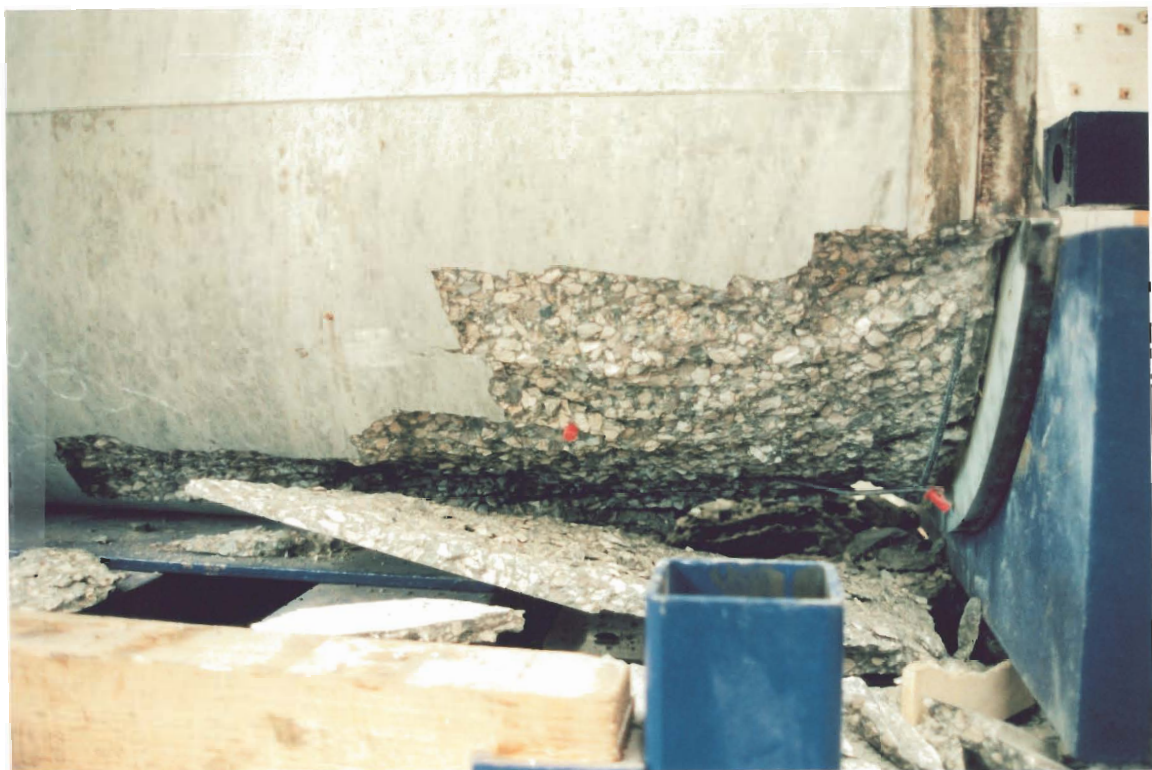
Plate D18 Pipe 8: Standard pipe with 2° chamfer (1.0° deflection)

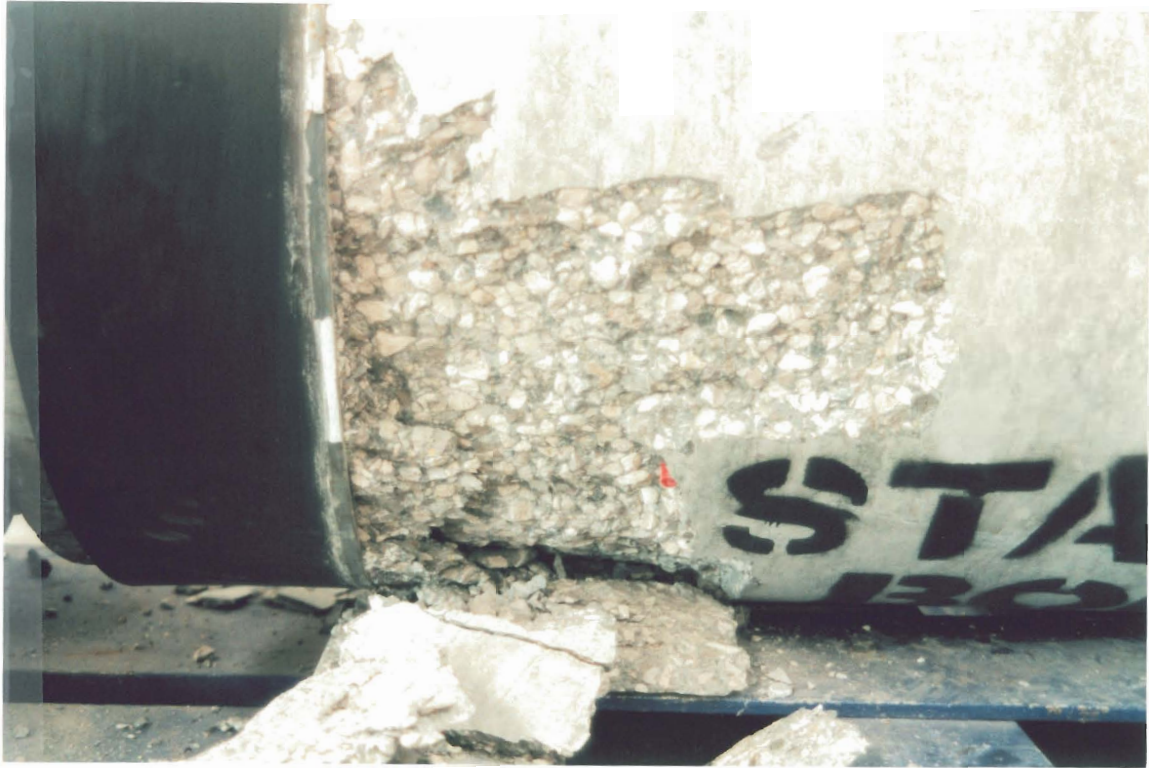
Plate D19 Pipe 9: Standard pipe with joint reinforcement (1.0° deflection)

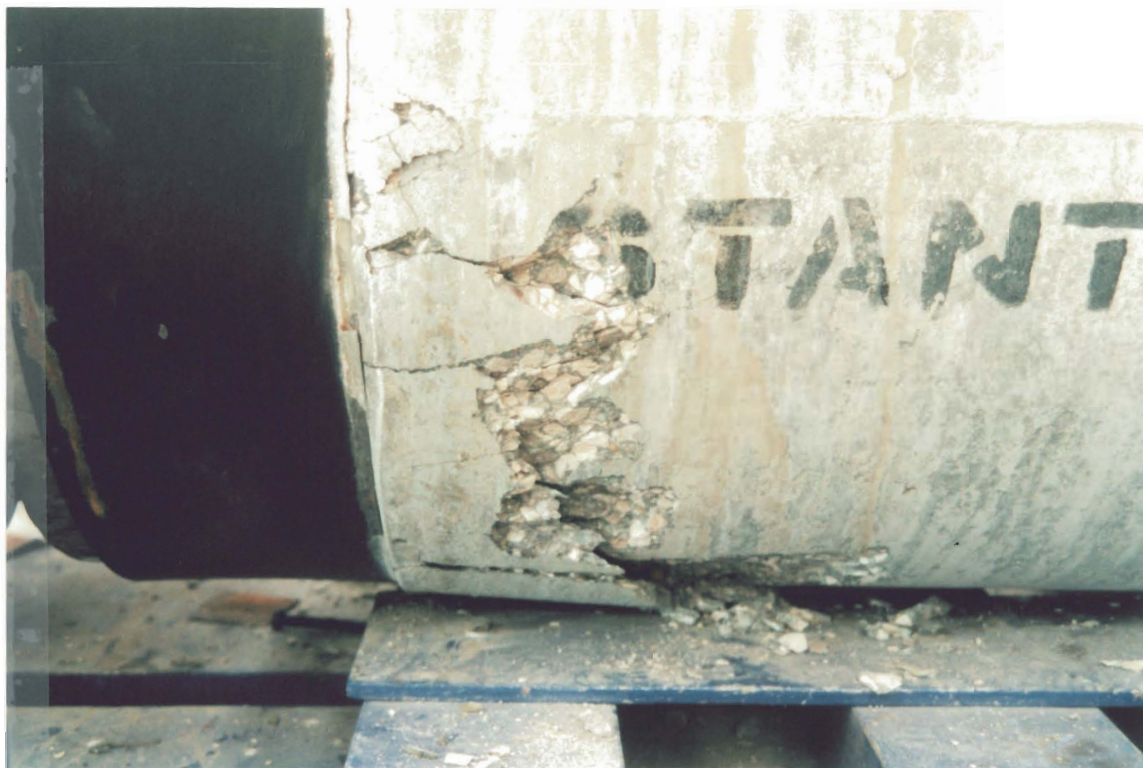
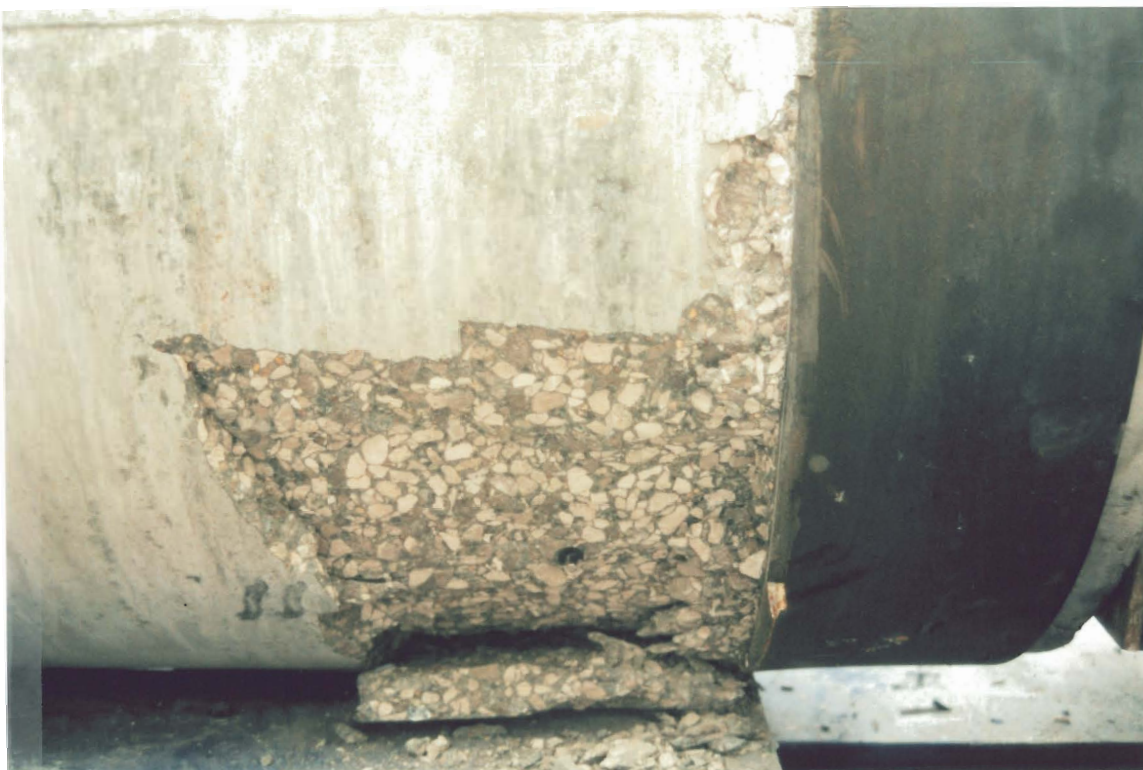
Plate D20 Pipe 10: Standard pipe with joint reinforcement (1.0° deflection)

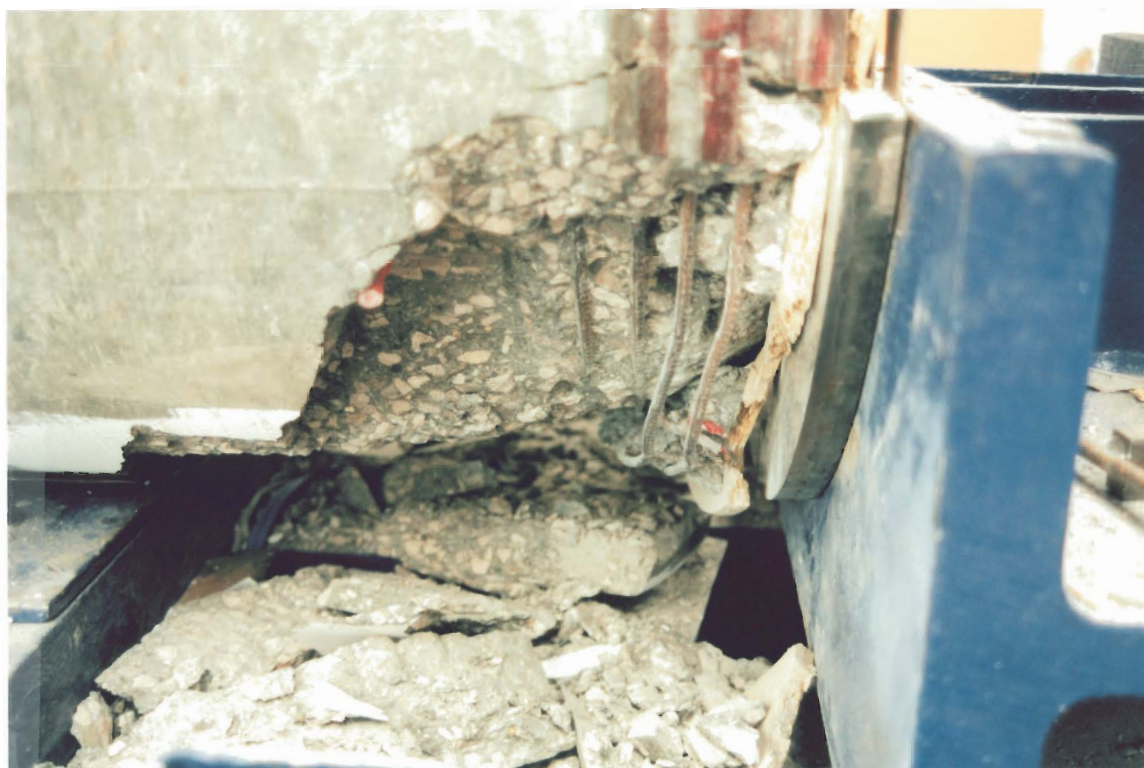
Plate D21 Pipe 11: Standard pipe with 3° chamfer and joint reinf't (1.0° deflection)

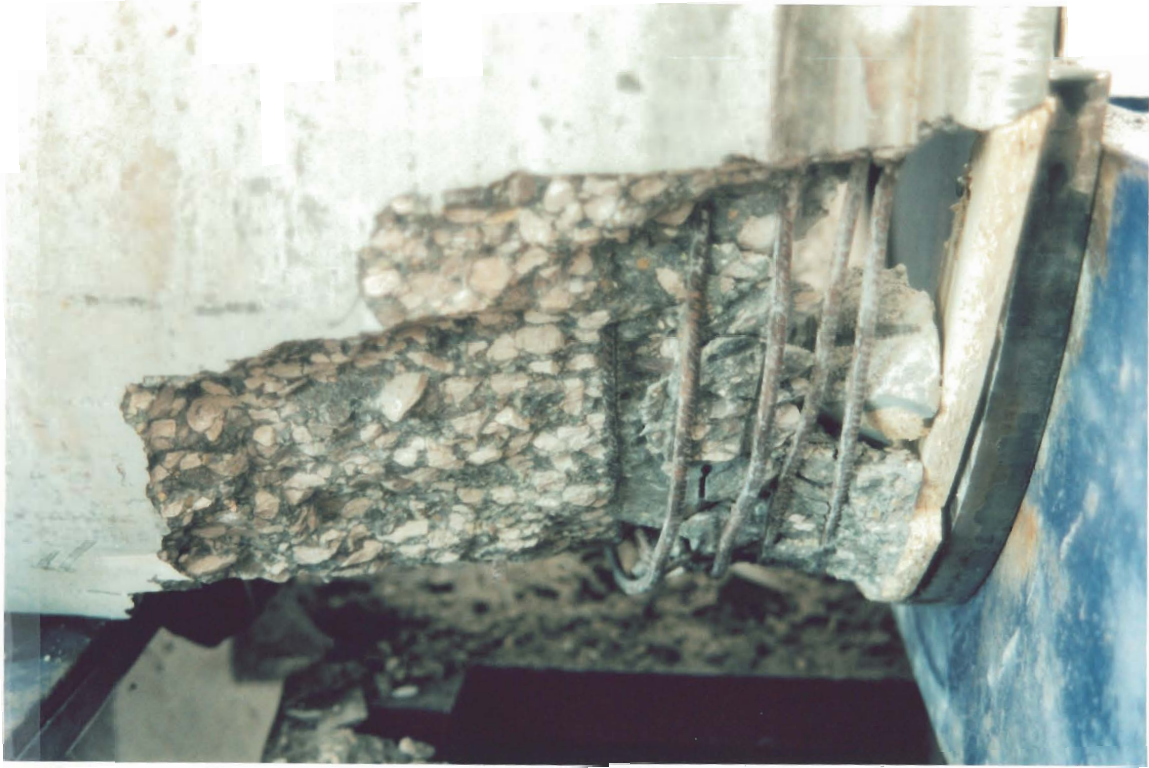
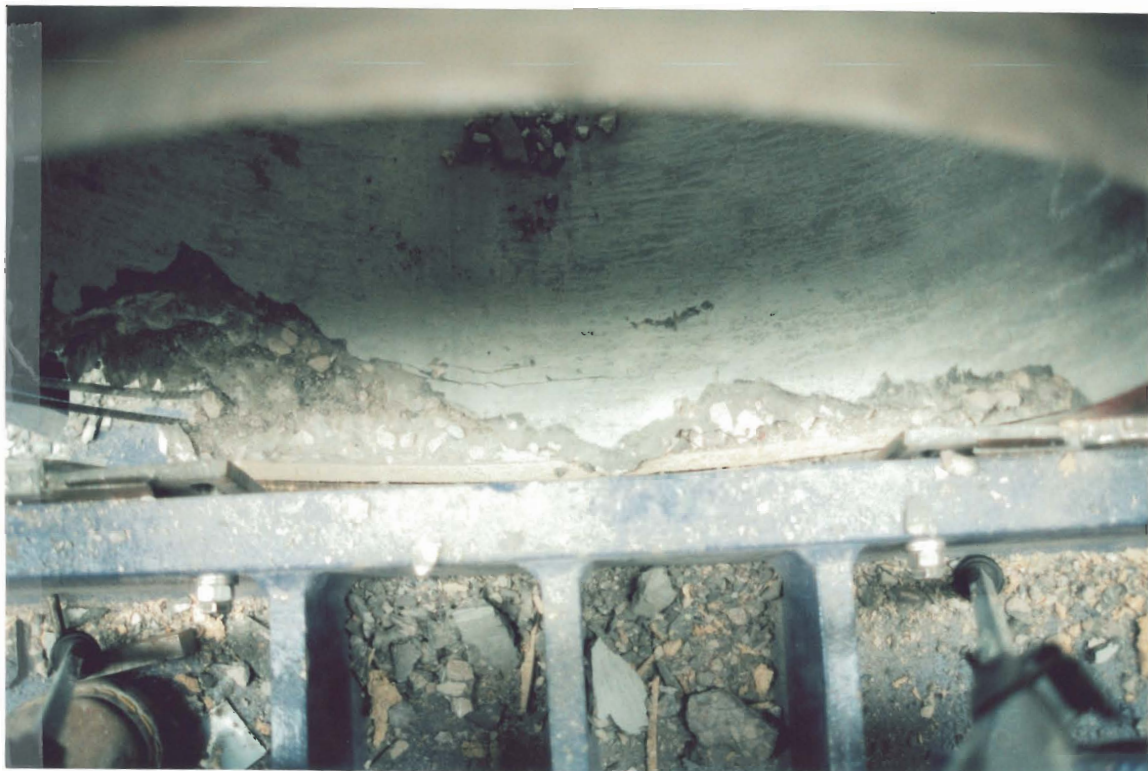
Plate D22 Pipe 12: Standard pipe with 3° chamfer and joint reinf't (1.0° deflection)

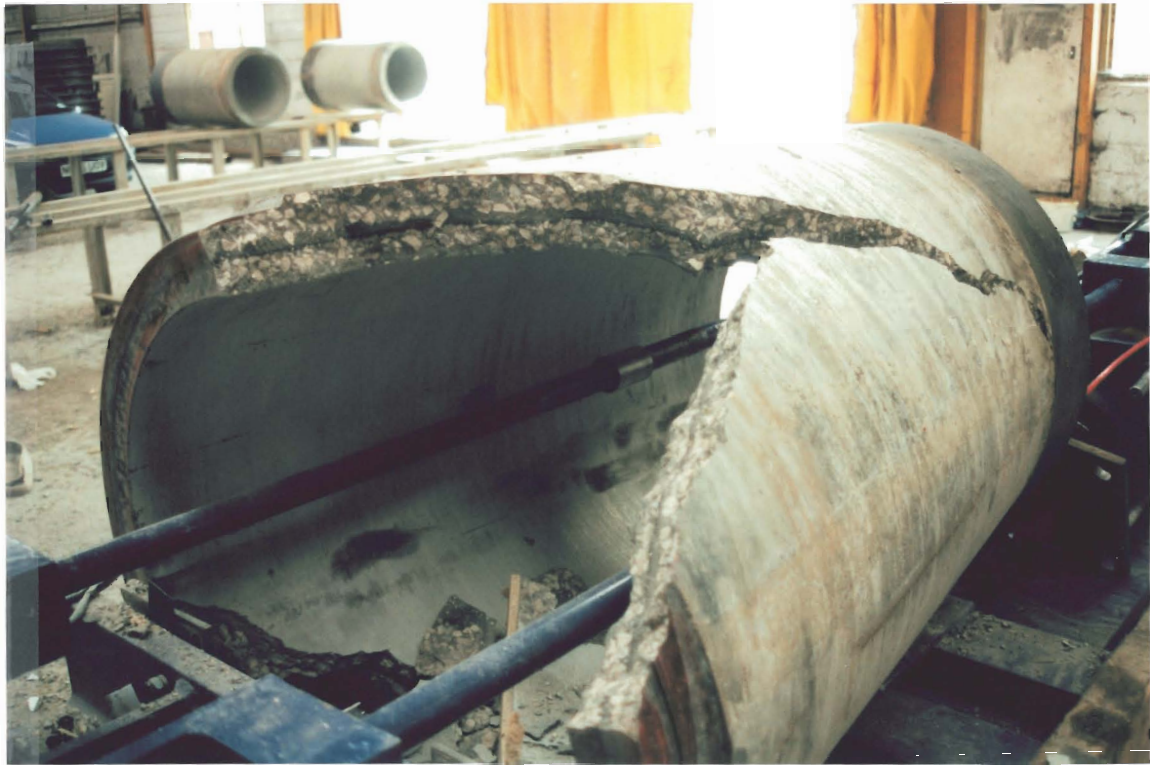
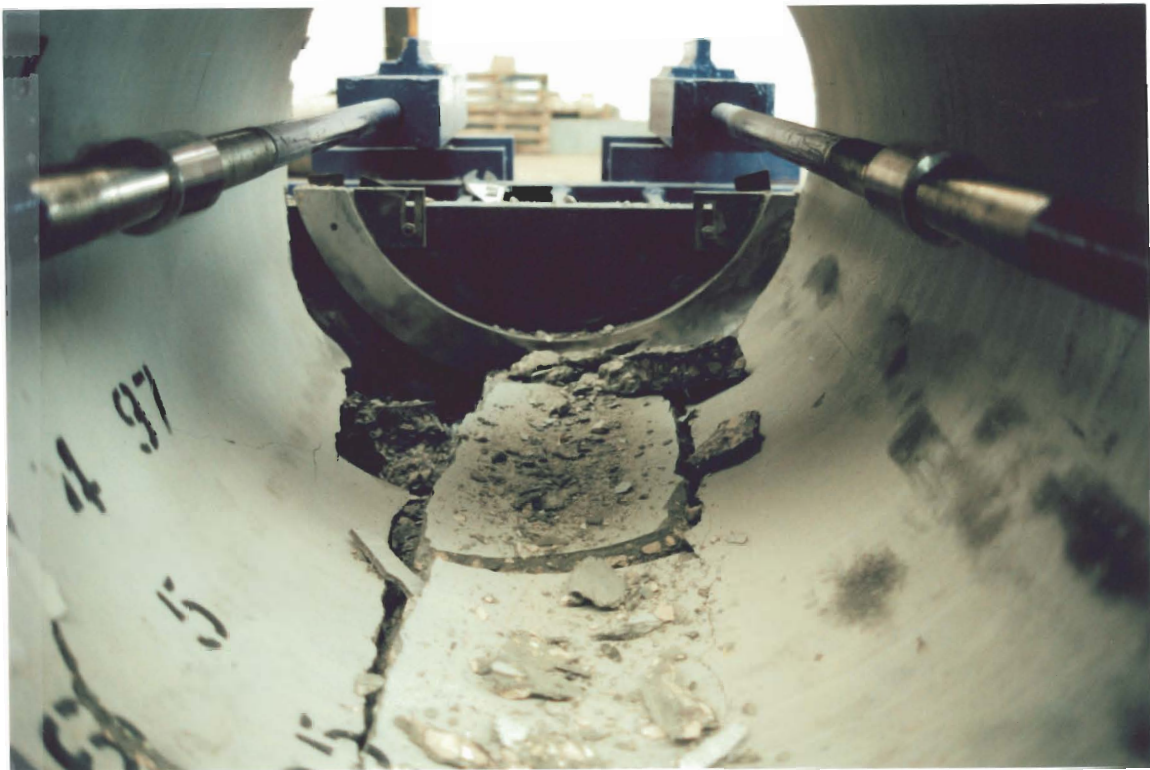
Plate D23 Pipe 13: Standard pipe unreinforced ( $1.0^{\circ}$  deflection)

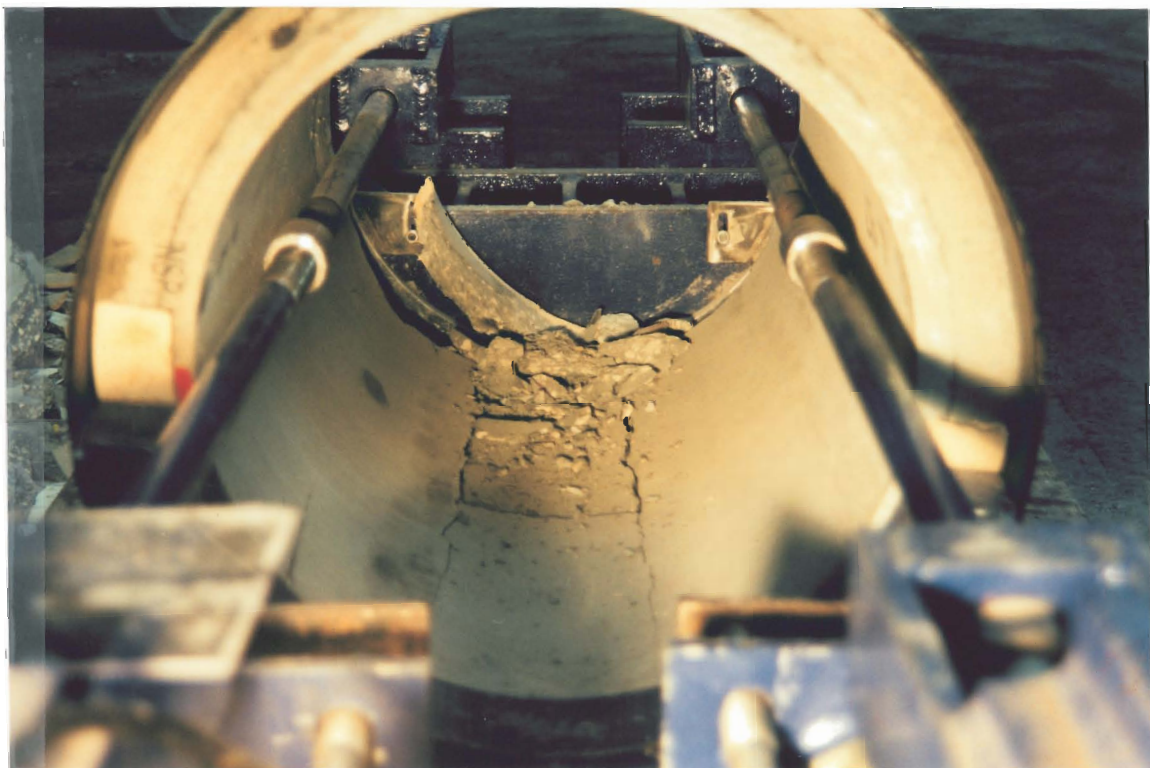
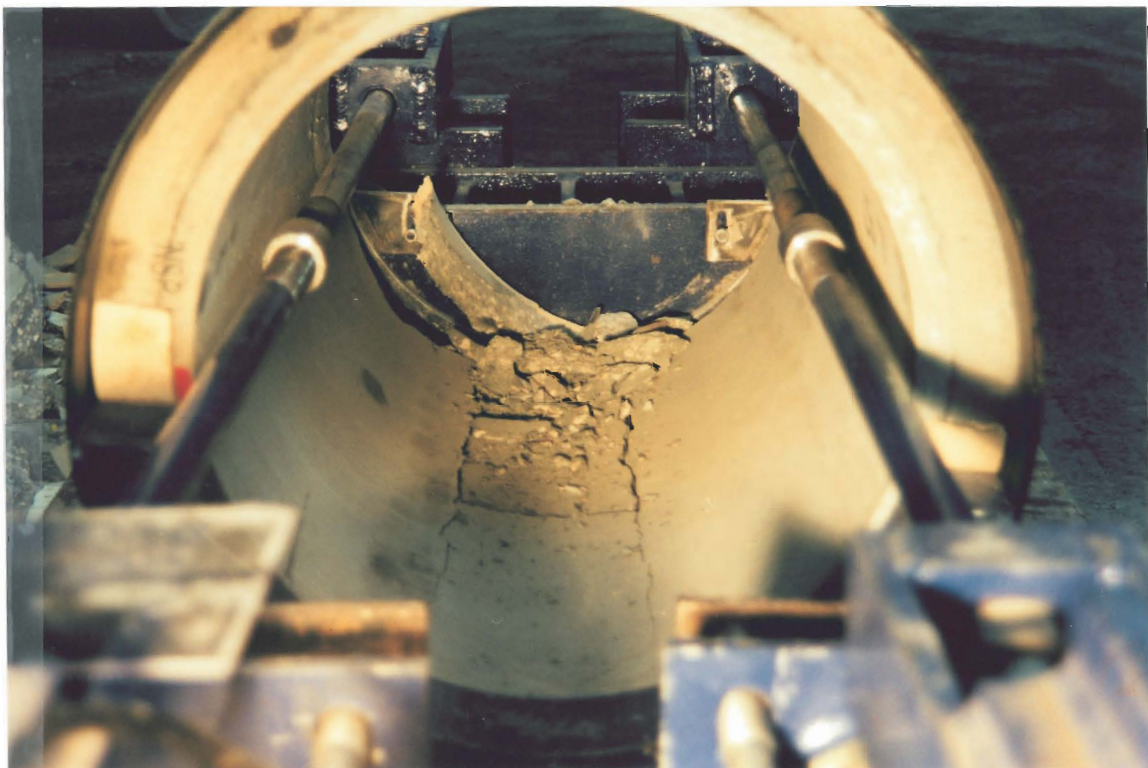
Plate D24 Pipe 14: Standard pipe unreinforced with 2° chamfer (1.0° deflection)

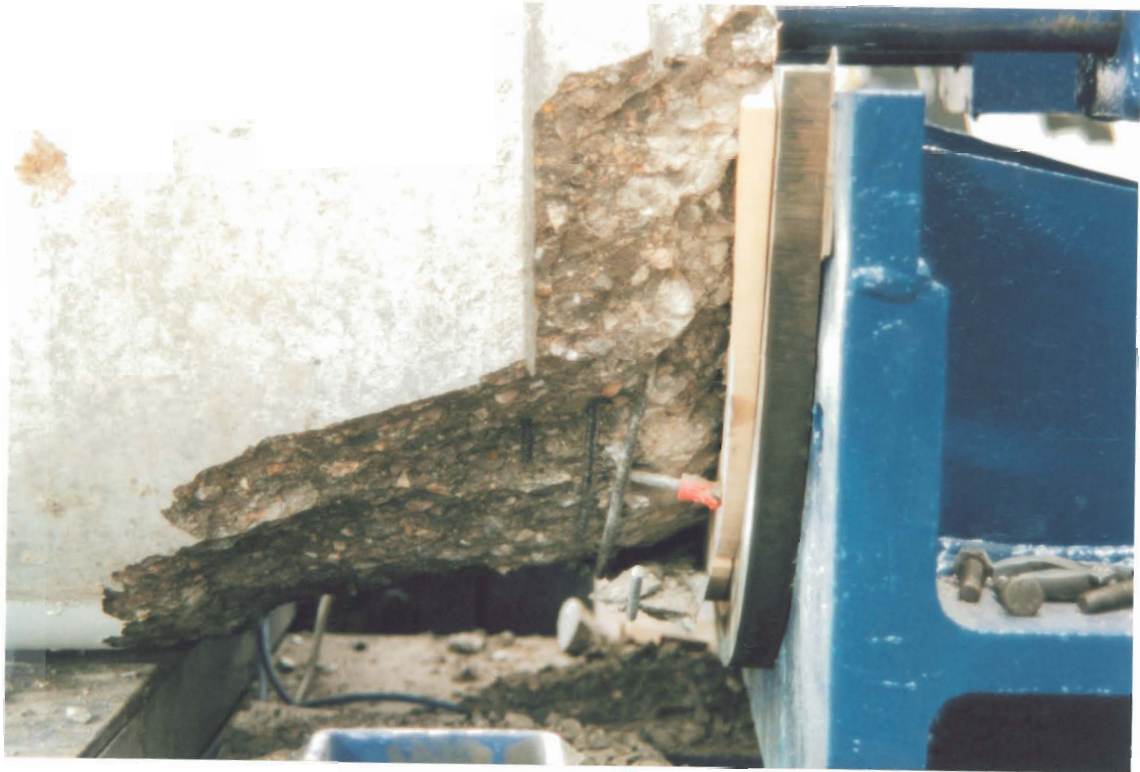
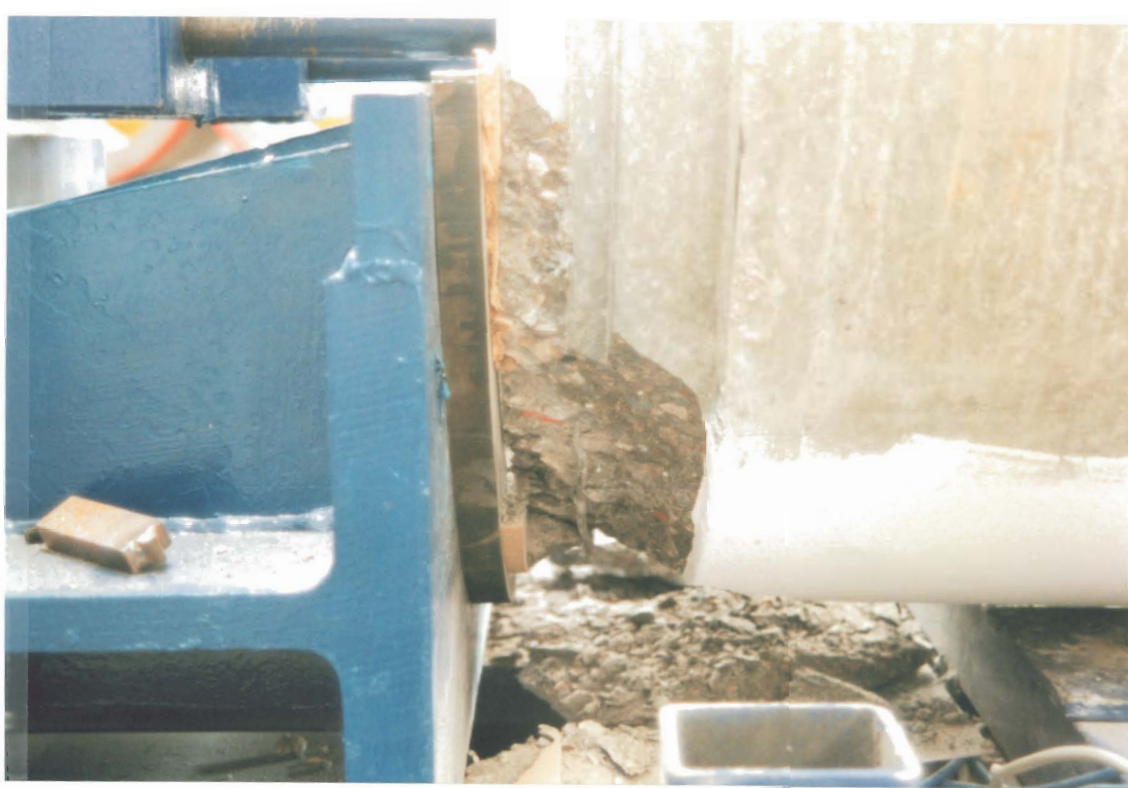
Plate D26 Pipe 2: Standard pipe ( $0.5^\circ$  deflection)

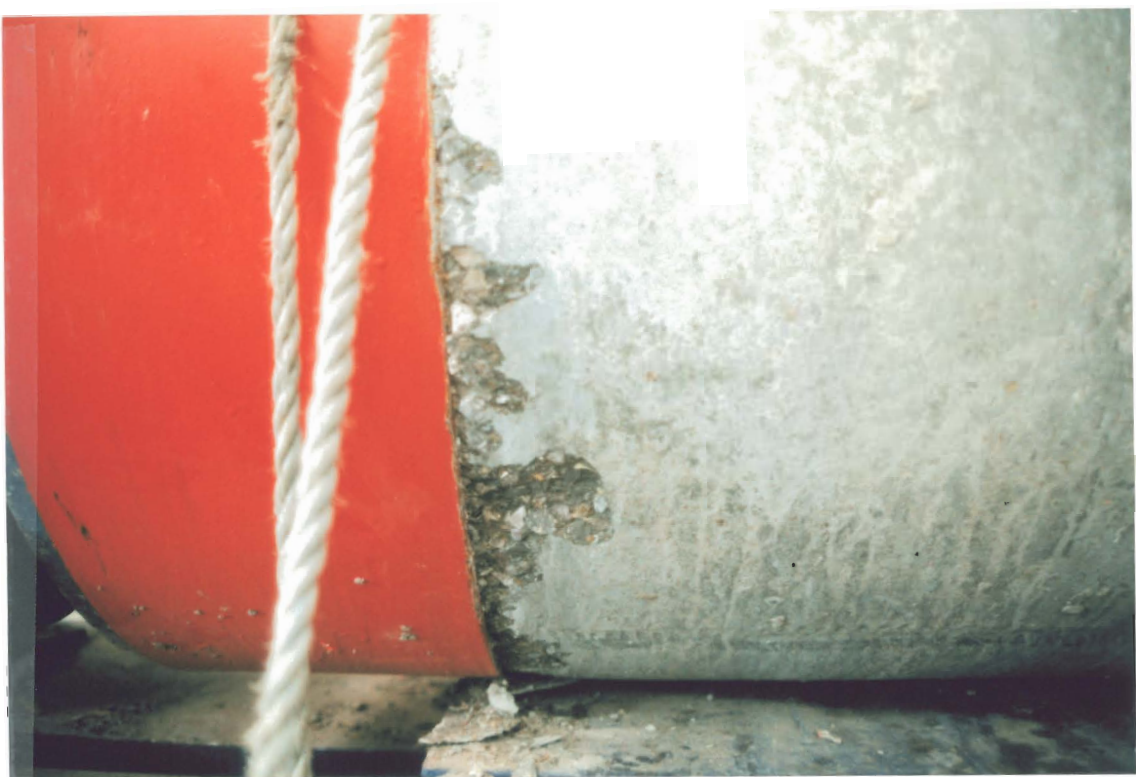
Plate D30 Pipe 6: Standard pipe with 2 presressed steel bands (0.5° deflection)

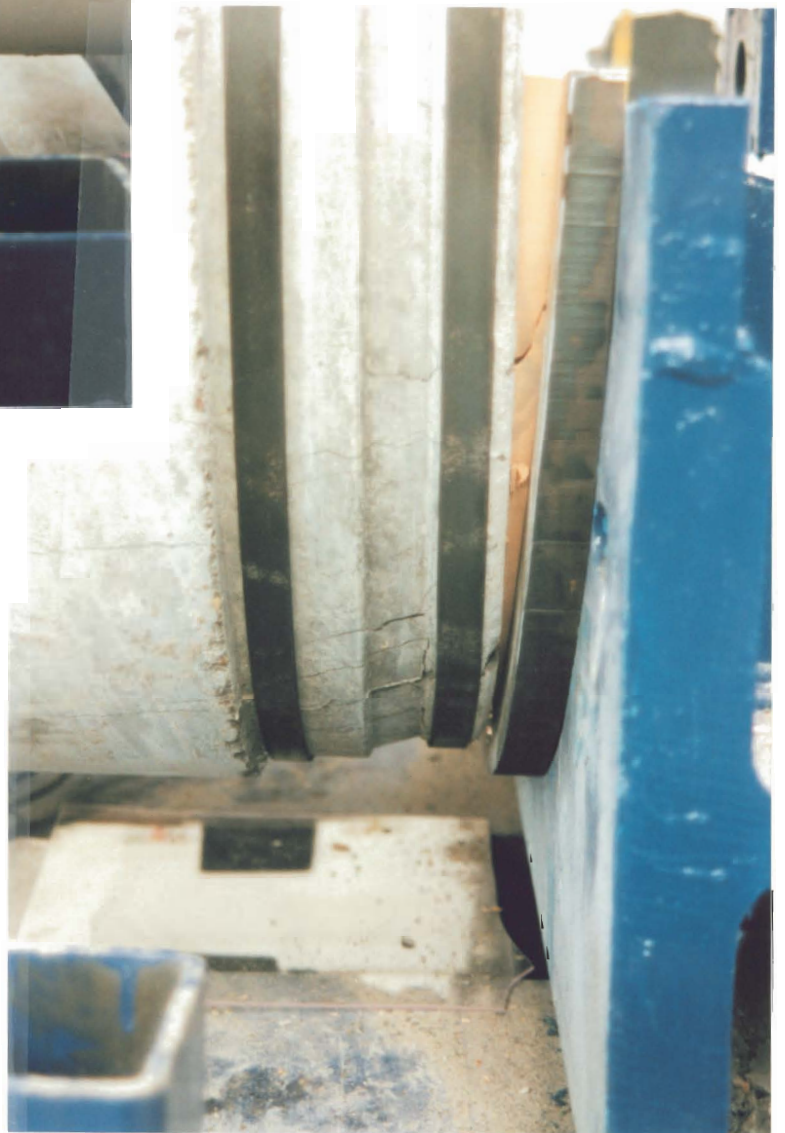
Plate D36 Pipe 12: Standard pipe with 2 pressed steel bands (1.0° deflection)
